Accessibility Audit of Footpaths and Public Hospitals in Dhaka (North and South) City Corporation Areas

Jan 2022

Prepared by

The Centre for Disability in Development (CDD)

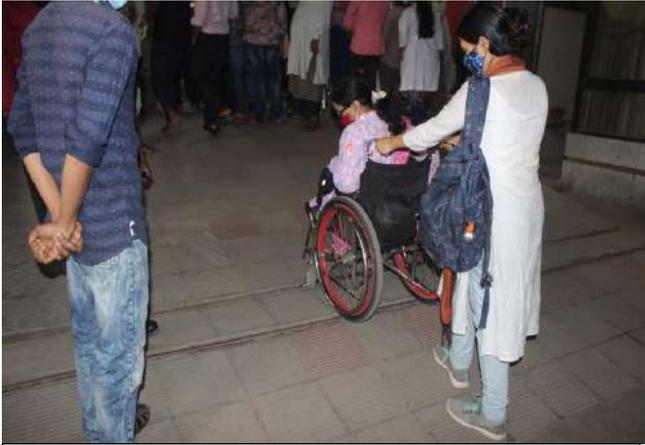
Findings	Gaps	Recommendations
<p>Main Entrance:</p> <p>The entrance ramp is a straight run ramp and is way too steep for wheelchair access, Pic-01.</p> <p>The measurement of the ramp is 4500mm width, 2440mm long.</p>	<p>The main entrance ramp alongside narrow stairs does not meet accessibility standards.</p>	<p>Alter the ramps according to the following universal design considerations: (details on Fig-03, Annexure-2)</p> <p>Recommended slope ratio (1:12) for the straight run ramp at the entrance should be 720 mm:8640 mm.</p>
<p>There is a wheelchair stand on the right.</p>	<p>Inadequate numbers of wheelchairs and inaccessible pathways.</p>	<p>Ensure sufficient numbers of a wheelchair at wheelchair stand along with accessible pathway.</p>
<p>Ramps:</p> <p>The ramp along the right side of the stairs is a</p>	<p>The ramp has no colour contrast handrails and tactile ground surface</p>	<p>According to universal design considerations, the recommended slope ratio of a ramp is 1:12 and width at least 1200mm wide. Add landings at top and</p>

Pic-01: Straight run ramp at entrance

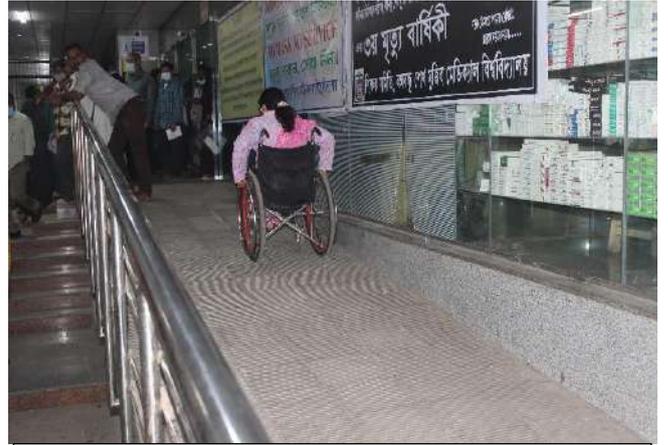
Findings	Gaps	Recommendations
<p>180° turn ramp with 1830mm width and 14325mm long, Pic-03. The slope of the ramp meets the universal design standards. The surface of the ramp slip-resistant and well-drained. It has a handrail on one side and landing at top and bottom and at the change of direction at 5181mm, width of this landing 1463mm and length 3400mm, Pic- 02.</p> <p>Stairs: To enter into the building there are stairs along the paved pathway, with 09 steps. The tread and riser of the steps are respectively 260mm and 180mm (1 to 6), 150mm (7 to 9)</p>	<p>indicators for people with special needs. The tactile ground surface indicators at the top and bottom landings are missing.</p> <p>Stairs do not meet accessibility standards. No colour contrast, handrails, and tactile ground surface indicators at top and bottom landings (Pic-?).</p>	<p>bottom and every change of direction (minimum 1200mm wide x 1500mm long). Details on Fig-05, Annexure-2</p> <ul style="list-style-type: none"> • Add handrails—that are continuous on both sides ~900mm high and that continue onto the top and bottom landings for 300mm before finishing. • Alter ramp surface—that is tactile ground surface indicators— at top and bottom landings for people with difficulty seeing (Fig-04, Annexure-2). • Curbs— on exposed edges (50mm high) <p><i>(Bangladesh national building code, 2020)</i></p> <p>Stairs at the entrance of the building should be modified to accessible stairs considering the following standards: (details on Fig-04, Annexure-2) mentioned below:</p> <ul style="list-style-type: none"> • Width—at least 1200mm wide between the handrails • Steps—that are 150mm high and 300 mm deep • Colour contrast strips on the edge of the step. • Handrails—should be continuous on both sides and at the middle, 900 mm high and circular in section and extend 300 mm beyond the top and bottom steps. • The diameter of 40-45mm will allow for a better grip. The gripping part must be at least 45mm from the edge of any obstruction (e.g., a wall) so that the person can wrap their fingers comfortably around the rail (Fig-5, Annexure-2). • The person must be able to move their fingers/ hands continuously along the rail so there should be no obstructions from rail supports that would mean a person has to remove their hand from the rail.

Pic-02: 180-degree turn ramp at the main entrance of OPD-1 building

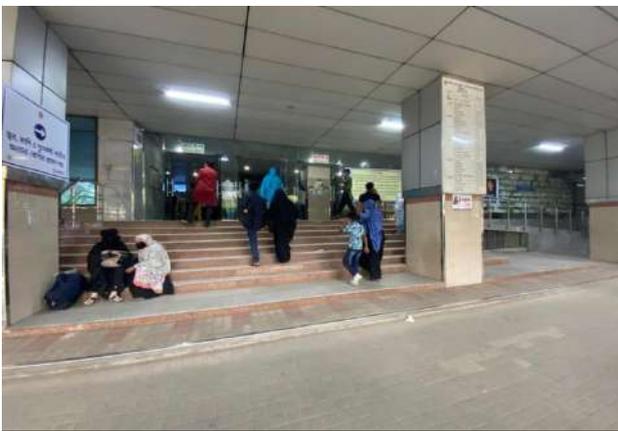
Pic-03: Stairs at the entrance door

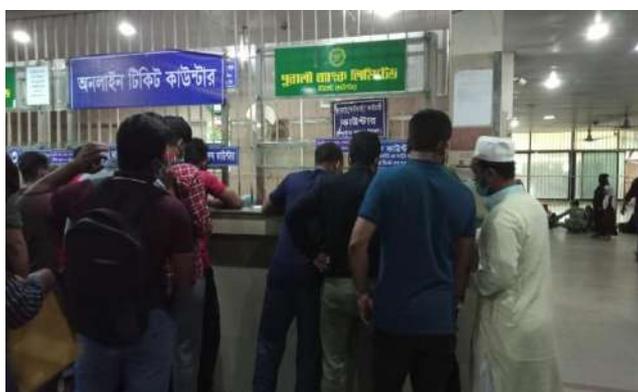
Findings	Gaps	Recommendations
<p>counters with a height of 1219mm. Pic-04 shown an inaccessible ticket counter for persons with disabilities at the OPD-1 building.</p>	<p>There are no signs at the ticket counter that give priority to older people, and persons (adults and children) with disabilities, and pregnant women. There is a lack of space at the counter area to allow privacy in communications. Light intensity is very low to read the doctor's prescriptions and all other documents comfortably. Background noises are also high in this area to hear the conversations clearly. This area is also crowded which obstructs easy movements. There are no sitting arrangements for the patients and visitors near the ticket counter.</p>	<p>level (<i>Guidance on the 2010 ADA standards for accessible design, 2010</i>). For details please see Fig-06, Annexure-2. Create a priority service delivery system for people with disabilities, older people, and adults with children, and pregnant women. Create a priority lane with appropriate priority signs, an example shown in Pic-12, Annexure-1.</p> <p>Staff training on promoting privacy to communicate with the client may improve the situation. The leading all edge of the counter should visually contrast with the work surface so that it is readily identifiable for the patient with low vision and visual impairments. The glazed screen should be clear and unobstructed. Posters and notices should not stuck the screens as these will obscure visibility and may be visually confusing for people with hearing impairments or people who is lip-reader. Where glazed screens are provided, a voice augmentation system (also called a speech enhancement system or voice transfer system) should be considered. This is likely to benefit everybody, including people with hearing difficulties, as the clarity and volume of speech are often reduced by the presence of a screen. A hearing enhancement system should be provided at all service counters for the people who use a hearing aid, e.g. Audio Induction Loop System. Use Loud speakers at all crowded counter area for the people with low hearing ability.</p>

Pic-04: Ticket counter at OPD-1 building do not meet accessibility standards

Findings	Gaps	Recommendations
<p>There is a Ticket counter at the OPD-1 building which is clearly visible from the entrance and the surface is level, smooth and non-slippery. There are eight identifiable ticket</p>	<p>Counters are not wheelchair user friendly at all.</p>	<p>The counter should have accessible height with knee clearance space and be marked with an international symbol of accessibility. The accessible counter surface should be a maximum of 760 mm above floor level and have clearance to the underside of 700 mm (<i>Guidance on the 2010 ADA standards for accessible design, 2010</i>). The general counter surface should be between 950mm and 1100mm above floor</p>

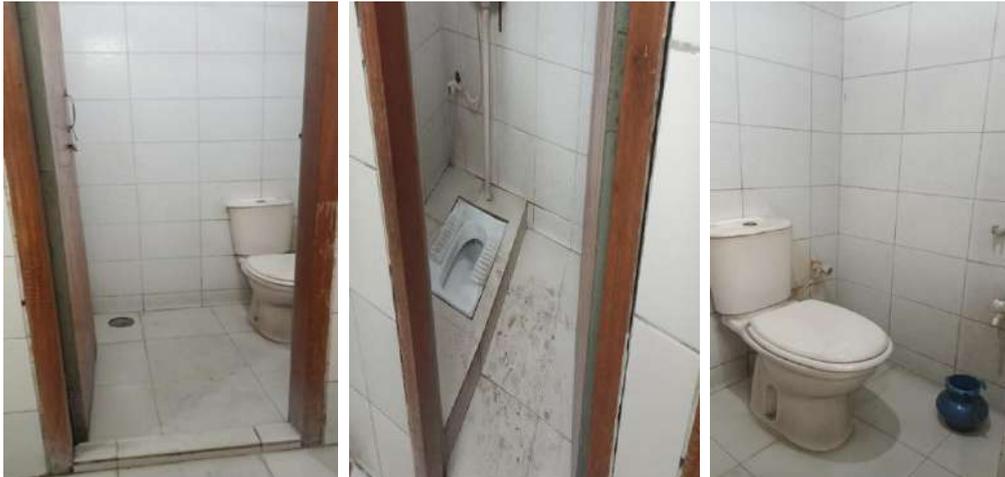
Pic: 05 Pic: 06 Pic: 06
 General toilets do not have grab rails, hand flush, insufficient space to maneuver a wheelchair and not accessible at all

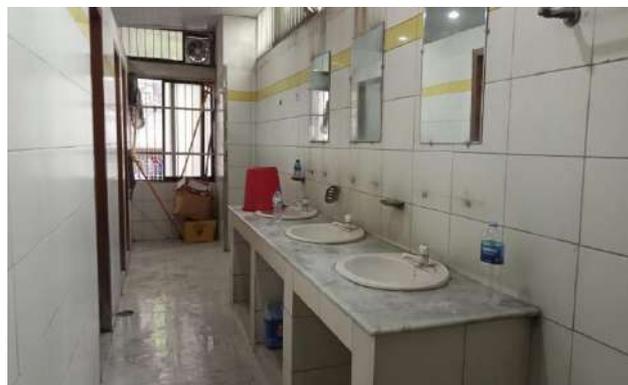
Pic-08: Washbasins inside the toilet block

Findings	Gaps	Recommendations
<p>There are two separate toilet blocks for males and females and three washbasins inside each toilet block.</p> <p>The height of the washbasins is 813 mm from the ground. There are 76 mm thresholds beneath the basins.</p> <p>Each basin has a twist-type tap. The height of the soap stand is 965 mm above the ground.</p> <p>The bottom edge of the mirror is 1270 mm above the ground.</p>	<p>The space in front of the washbasin is very narrow to move a wheelchair.</p> <p>Mirror, soap and water taps of washbasins are out of reach of wheelchair users as shown in (Pic-19, Annexure-1).</p> <p>Threshold and adjacent support walls under the basins make obstructions in wheelchair movement.</p> <p>Existing water taps are not accessible for all.</p> <p>No colour contrast is present.</p>	<p>Modify at least one washbasin at each toilet block into an accessible washbasin by using considerations shown in Fig-14, Annexure-2.</p> <p>Height: The top of the basin height shall be 850mm maximum and the bottom height of the basin shall be a minimum 680mm from the floor level.</p> <p>Clearance: 200mm minimum knee and 230mm minimum toe clearance.</p> <p>Water tap: Automatic or lever operated.</p>

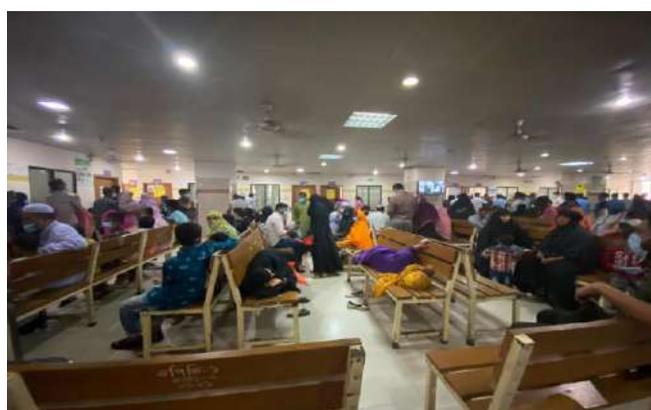
Pic-20: Outdoor consultation waiting area

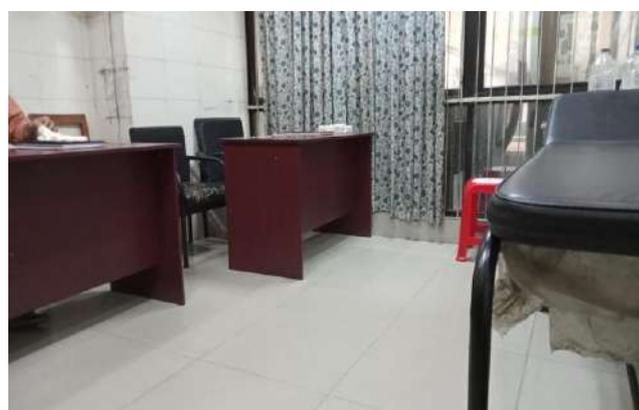
Findings	Gaps	Recommendations
<p>attendants, Pic-21, Annexure-01.</p> <p>Every table is 1000mm high and no adequate legroom for wheelchair users.</p> <p>The patient bed is a fixed type of bed with a height 750mm and a width of 600mm.</p>	<p>Bed height is not accessible for a patient, especially a wheelchair user, to transfer from wheelchair to bed.</p>	<p>exam table is recommended, Fig-21, Annexure-02 ("<i>Accessible Medical Examination Tables and Chairs ADA National Network</i>", 2021).</p> <ul style="list-style-type: none"> • Make sure examination rooms provide clear floor space for a person to turn in a wheelchair or scooter comply with Fig: 22, Annexure-02. Turning space: Minimum 1525mm. • Clear floor or ground space: Minimum 760mm by 1220mm;

Pic-21: Doctors consultation room & patient

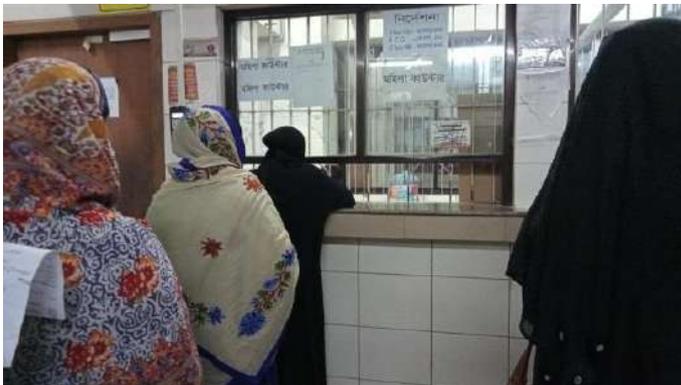
Findings	Gaps	Recommendations
<p>The surface is stable, flat, non-slip and non-glare. There is enough lighting inside the room. There is a pathology counter with a 1220mm height and does not allow a wheelchair user to use the counter comfortably, Pic-23, Annexure-01. There are some tables with no leg room and chairs but no bed for collecting blood samples, Pic-23, Annexure-01. The table height is 750mm.</p>	<p>physical, and intellectual disabilities. There are no functioning emergency alarms with both visual and audible signals and no clear signage indicating accessible escape routes.</p>	<p>broadcasting of different videos on health care management may reduce loud background noises. Install a functioning emergency alarm with both visual and audible signals and also clear signage indicating accessible escape routes. Alter counter or add at least one accessible counter complying with section 3.4.1.5. Ticket counter, page no.</p>

Pic-09: Existing pathology counter

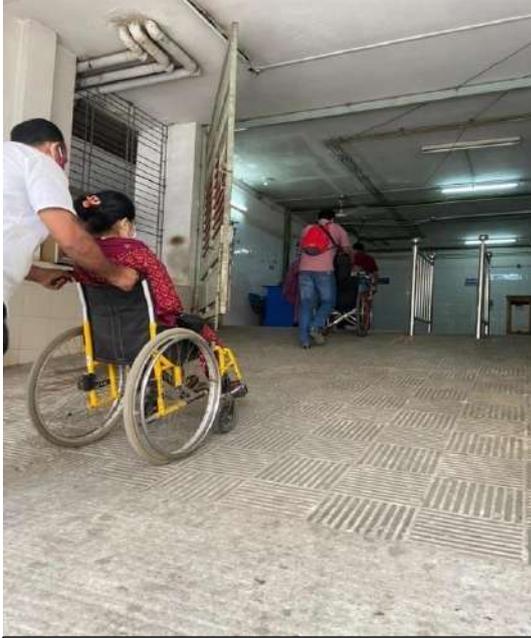
Pic-10: Entrance of emergency unit

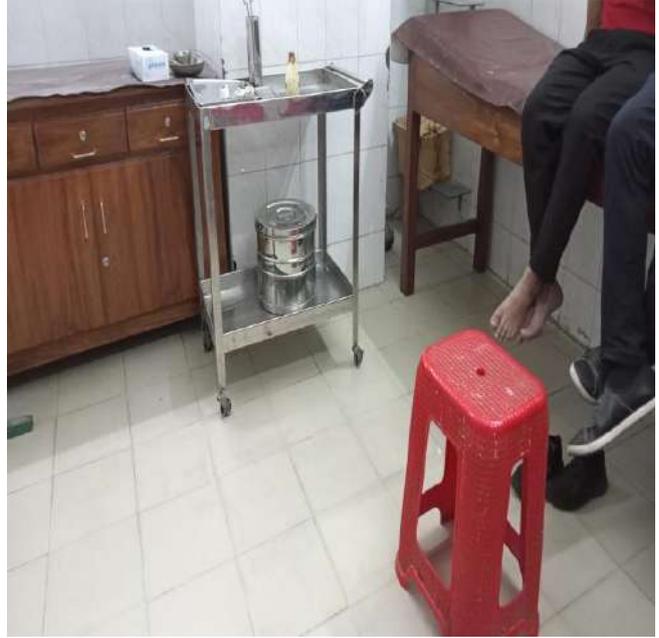
Pic-11: Emergency orthopedic room

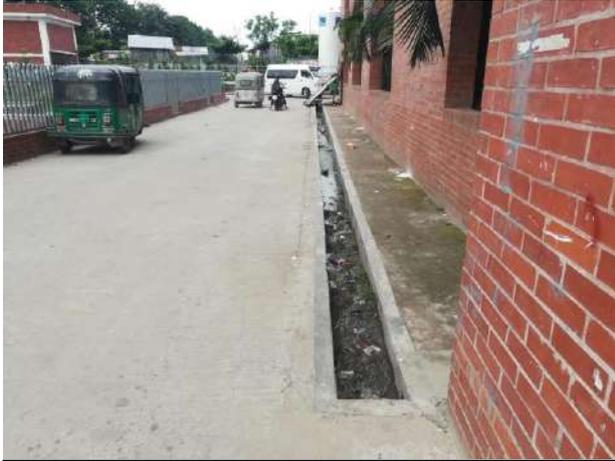
Pic-12: New building access route

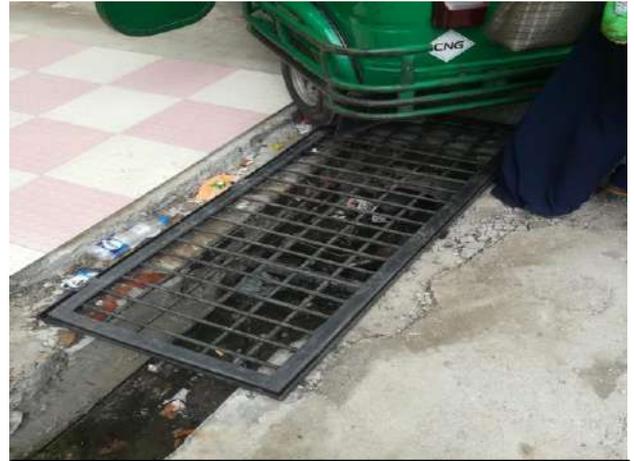
Pic-13: Drainage is not properly covered

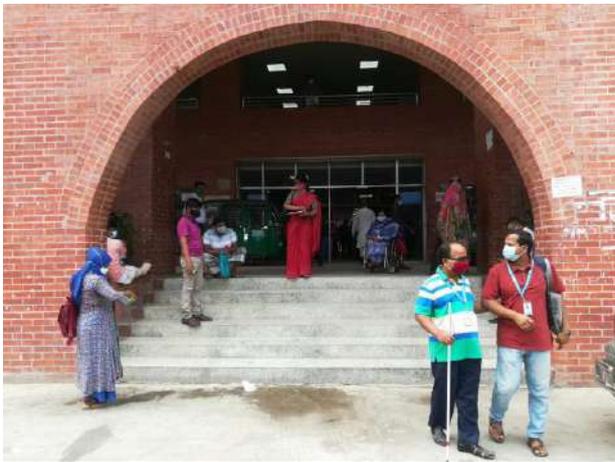
Pic-14: Stair at the main entrance

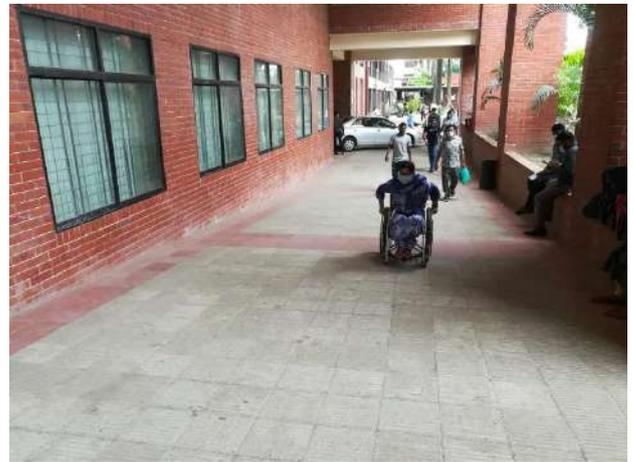
Pic-15: Ramp at the main entrance

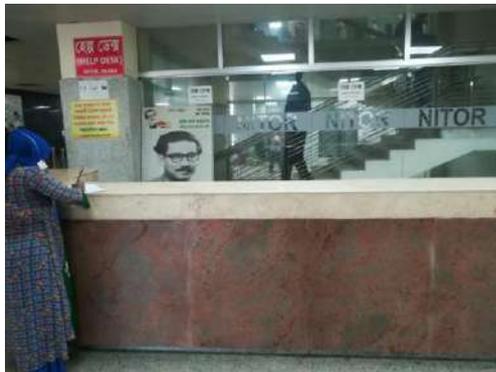
Pic-16: The help desk counter is not accessible for a person using wheelchair

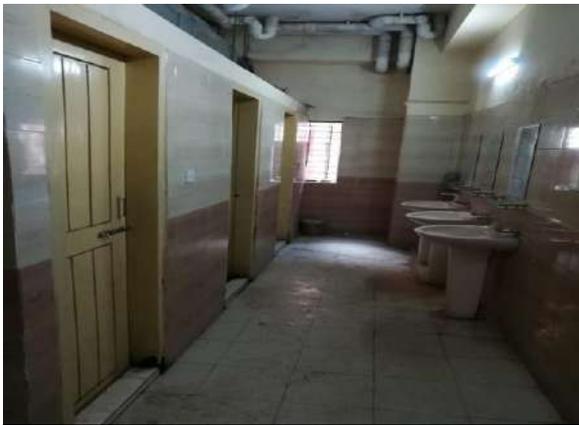
Pic-19: Three cubicles & hand washing space inside the toilet block

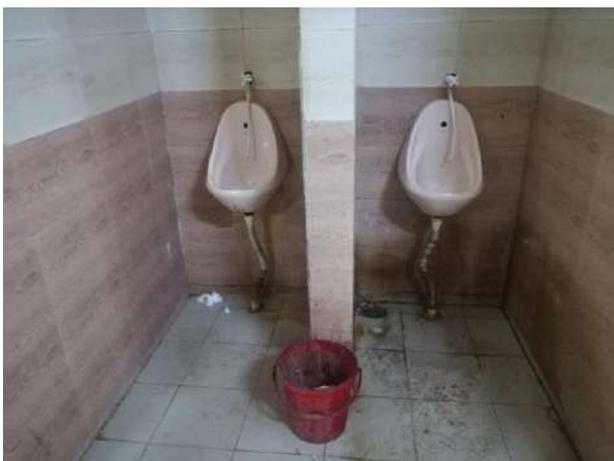
Findings	Gaps	Recommendations
<ul style="list-style-type: none"> Distance from the sidewall to the centre of the toilet pan 508mm, Pic-20 <p>Urinals height is 737mm, chamber width and depth are respectively 737mm and 304mm, Pic-21.</p> <p>The rim of the washbasin is mounted at a height of 813mm maximum from the floor. The height of soap dispensers is 864mm. The bottoms of the mirrors are 1168mm and the top 1787mm from the floor level.</p>

Pic-21: Urinals at the male toilet block

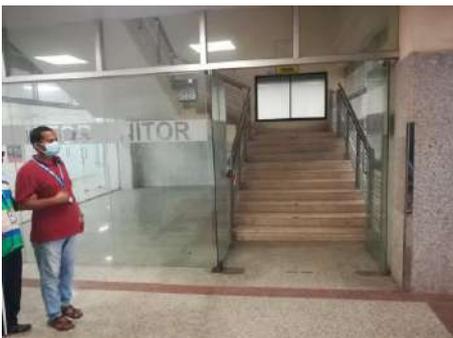
Pic-22: Stair alongside the corridor

Findings	Gaps	Recommendations
<p>The corridor is 5182mm wide. The surface of the corridors is stable, flat, non-slip and non-glare. Corridors door meet the accessibility requirements. It is a glass-made swing door. This door opens inward and has a clear open space of 1737mm. The door handle is 305mm, D-shape. The handle position is between 965mm to 1270mm from floor level. The stair along the corridor does not meet the accessibility standards, Pic-22.</p> <ul style="list-style-type: none"> • Width: 1829mm • Steps 127mm high and 305mm deep. • No appropriate color contrast • Handrails are continuous, at both sides and 991mm in height. • Landings 1829mm in length and 2134mm in wide. <p>There are ramps alongside the corridors, do not meet the accessibility requirements.</p> <ul style="list-style-type: none"> • Type of ramp: 180-degree turn • Width: 1981mm • No handrails present <p>Landings are present after every 25298mm vertical rise, Length 4816mm and 2896mm width</p>	<p>Corridors are not free from obstacles and hazards. Patients and their attendants are flooring in the corridor. Obstacles are not contrasting colors in the corridor. There are no clear signs and pictographs providing directions to rooms, elevators, and stairs with color contrast, non-glare, large print and pictures. There is no tactile paving with color contrast. Light intensity is low along with the landings and corridors. No functioning audio-visual fire alarms. No clear signage and pictograph indicating accessible escape routes.</p> <p>Some signboards/ directions are handwritten and too small to notice No proper indicators for visually impaired individuals.</p>	<p>Any obstacles in the corridor area shall be avoided. All obstacles shall be appropriate colour contrasted with the background. Use appropriate signage and indications. Signage shall comply with 3.4.1.1. Outside of the hospital, page-12. Install appropriate colour contrasted tactile indicator comply with Fig-03, Annexure-02. Increase the lighting to a maximum of 11 LPD (w/m^2). Install an audible and visible emergency alarm system and clear directional signage of accessible escape routes. Stair shall be altered into accessible stair complying with section 3.4.1.3. Entrance - Stairs, page-15. The ramp shall be altered and comply with 3.4.1.3. Entrance - Ramps, page-15.</p>

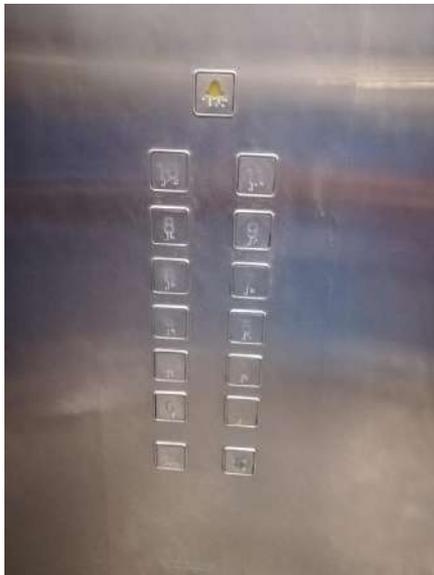
Findings	Gaps	Recommendations
<p>There are four elevators in the new hospital building.</p> <p>The length of every lift car is 2235mm and the width 1829mm.</p> <p>The door width is 1295mm.</p> <p>The doors open and close automatically.</p> <p>The height of the call buttons is 1081mm from floor level. Braille language is used for persons with visual impairment, Pic-23.</p> <p>Horizontal grab bars height is 1116mm, Pic-24.</p>	<p>There is no audible and visual indicator for a person with sensory and cognitive impairments.</p>	<p>Install appropriate signage and directional signage to locate elevators and different departments on each floor.</p> <p>Install audible and visual indicators for the person with sensory and cognitive impairments.</p>

Pic- 23: Elevator's control board

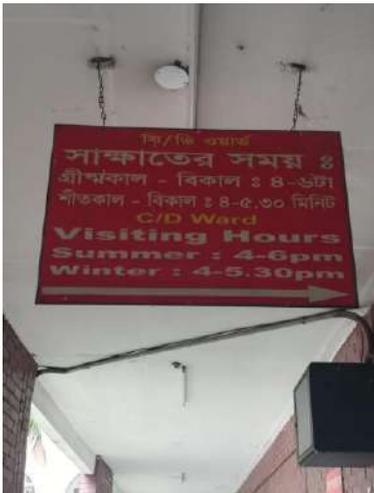
Pic-25: Hanging directional signage of General Ward

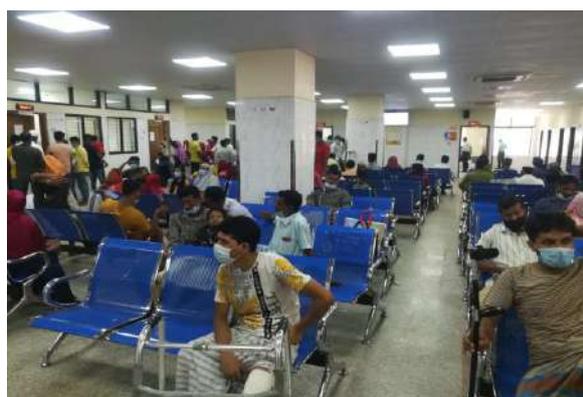
Findings	Gaps	Recommendations
<p>Doctor's consultation rooms are situated on the ground floor of the new building. There is a waiting area. This area has 96 total sitting arrangements in three rows of benches. All benches are fixed, Pic-29. Surface level, smooth and non-slippery. There are two categories of consultations room. Room numbers 1 & 2 are reserved for professors and rooms number 3, 4, 5 & 6 are for medical officers. The dimensions of these rooms are 2896mmx3556mm. Rooms 1&2 are comparatively large than other rooms. The door width of rooms 3, 4,5 and 6 is 889mm. These rooms have two chairs, one desk with 152mm knee clearance. There is a height-adjustable bed in every consultation room. There is 1118mm clear space to move in the room.</p>	<p>There is no reception counter. No priority sign in the waiting area that gives priority for people with disabilities, older people, adults with children and pregnant women. No space for wheelchairs. The waiting area is not clear of obstacles and hazards. Some monitors showing videos instead of the serial number.</p>	<p>A reception counter in this area may be useful for the patient to receive services more easily. The reception area shall comply with section 3.4.1.5. Ticket counter, page 21. The outdoor doctor's consultation room and waiting area shall comply with 3.4.1.14. Outdoor doctor's consultation room and waiting area, page-41-42. Display serial number on the monitor along with calling out loud.</p>

Pic-29: No special area was reserved for persons with disabilities

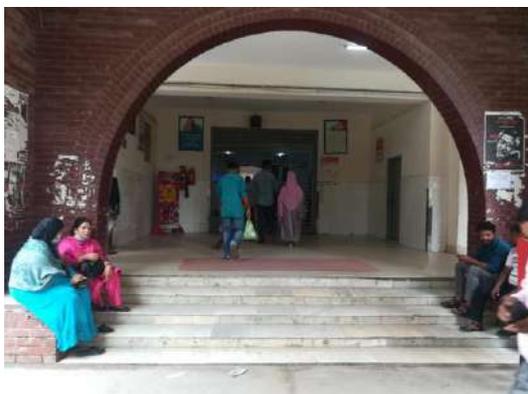
Findings	Gaps	Recommendations
<p>Emergency unit situated on the ground floor of the old hospital building. There are a stair and a ramp at the entrance of the emergency unit.</p> <p>The stair has 5 steps with 4572mm width and 356mm depth. 1st step's height is 51mm, 2nd to 4th step's height is 114mm and 5th step's height is 152mm, Pic-30.</p> <p>The ramp is 1194mm wide and 4267mm long. The handrail is 965mm high. The landing space's dimension is 5182mmx1194mm, Pic-31.</p> <p>A 2235mm pathway leads to the emergency ticket counter. There are two ticket counters of the same height (1029mm).</p> <p>The entrance of the emergency unit has enough clear space.</p> <p>There are eight emergency bed facilities. All are fixed types of beds and two categories with 559mm and 689mm in height. There is a 559mm gap between two beds, Pic-32.</p> <p>The height of the switchboard is 1651mm.</p> <p>The emergency doctor's room is 864mm wide with 762mm door clearance, Pic-33.</p> <p>There is an emergency X-ray room with a 1397mm door width and 1295mm door clearance.</p> <p>X-ray bed is fixed with a height of 762mm, Pic-34.</p>	<p>The emergency unit is not well signed.</p> <p>No directional signage.</p> <p>The stairs and ramp do not meet accessibility criteria.</p> <p>X-ray bed does not meet accessibility criteria.</p>	<p>Install appropriate signage and directional signage.</p> <p>Alter stairs and ramp, shall comply with section 3.4.1.3. Entrance, page-15.</p> <p>The emergency unit shall comply with section 3.4.1.18. Emergency Unit, page-50.</p> <p>For easy transfer from a wheelchair to a table a height between 432mm to 483mm adjustable exam table is recommended, Fig-21("Accessible Medical Examination Tables and Chairs ADA National Network", 2021).</p>

Pic-30: Stair at emergency entrance

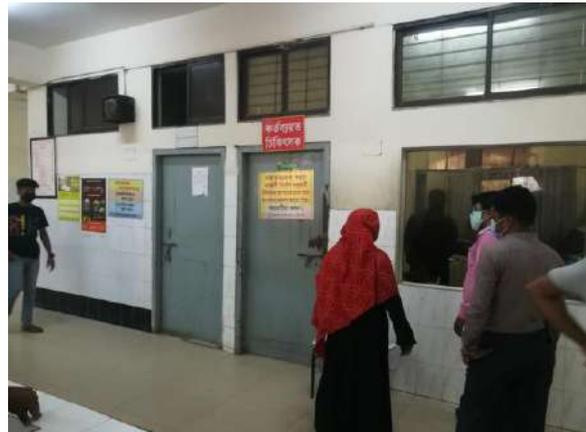
Pic-33: Some assistance is required for persons with disabilities to get services from the emergency unit

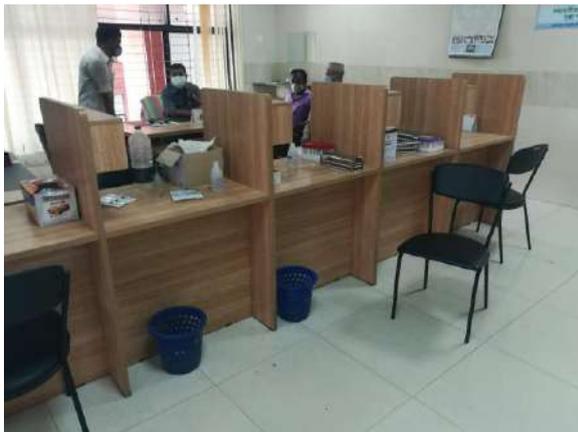
Findings	Gaps	Recommendations
<p>Every counter is 749mm long and 203mm knee clearance, Pic-35</p> <p>There is a toilet block with three toilet cubicles and a handwashing space with three basins,</p> <p>There is 1219mm available space in between washbasins and toilet cubicles doors.</p> <p>The main toilet block door width is 749mm. There is a 51mm high threshold. The door lock height is 990mm and liver system. Pic-37</p> <p>The switchboard height is 1321mm.</p> <p>Every toilet cubicles dimension is 1219mm×1067mm.</p> <p>Toilet pan height is 432mm.</p> <p>There is 305mm free space at the front, 356mm from the sidewall and 610mm at the non-side wall of the toilet pan.</p> <p>Hand shower height is 915mm.</p>

Pic-35: No signage of priority lane for persons with disabilities at sample collection counters

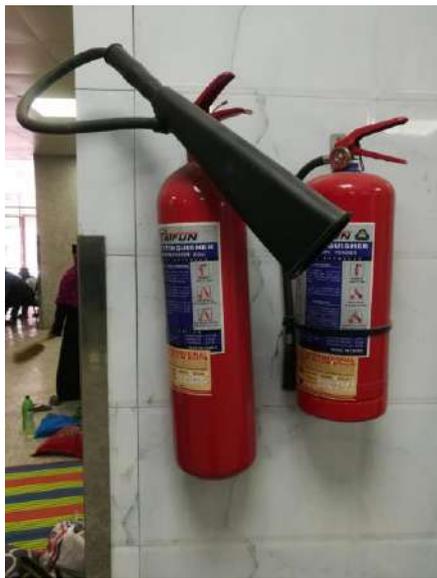
Findings	Gaps	Recommendations
<p>There are no fire exit routes. There are fire extinguishers and fire buckets.</p>	<p>All fire extinguishers are already date expired, Pic-38. No emergency guideline is written beside the fire extinguishers/hosepipe as to how to use them, Pic-39. No emergency lights to alert persons with hearing disabilities during the fire.</p>	<p>Put poster/visual guidance on how to use emergency tools besides the tool. Install emergency alerting lights. Emergency Exit shall comply with section 3.4.1.16. Emergency exit, page-47.</p>

Pic-38: More fire extinguishers are required having expiry date and trained staff to use during any emergency

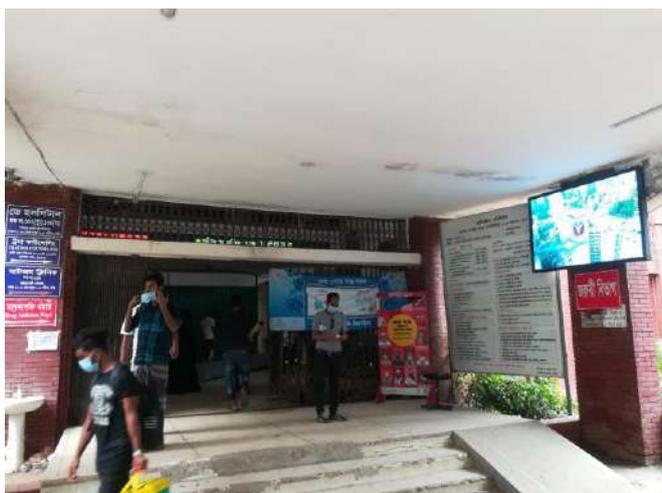
Pic-40: Inaccessible straight ramp and stairs

<p>(Bangladesh national building code, 2020)</p> <p>Install at least one accessible parking space. The parking area shall comply with 3.4.1.2. Parking, page-13.</p> <p>Add tactile paving of contrasting colour at pathway indicating towards facilities and services; Fig 03. Alter pathway surface smooth, flat and non-slip. Remove all obstacles from the pathway.</p> <p>Alter entrance stair to an accessible stair. Accessible stairs shall comply with section 3.4.1.3. Entrance - Stairs, page 16.</p> <p>Ensure enough wheelchairs available near the accessible entrance.</p> <p>Install appropriate building map, directional signage indicating an emergency, accessible facilities and all departments.</p> <p>As there is a lack of space in front of the entrance, it is recommended to install an accessible ramp at the left side of the entrance area, Pic-41. Accessible ramp shall comply with section 3.4.1.3. Entrance – Ramp, page-16.</p>	Viewing distance (m)	Symbol size (mm)	Up to 7.0	60x60	7.0 to 18.0	100x100	Above 18	200x200 to 450x450
Viewing distance (m)	Symbol size (mm)									
Up to 7.0	60x60									
7.0 to 18.0	100x100									
Above 18	200x200 to 450x450

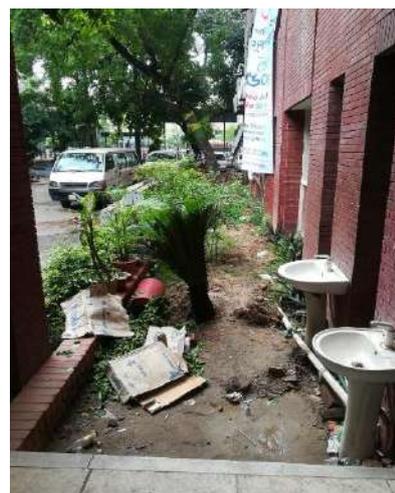
Pic-41: Recommended space for ramp

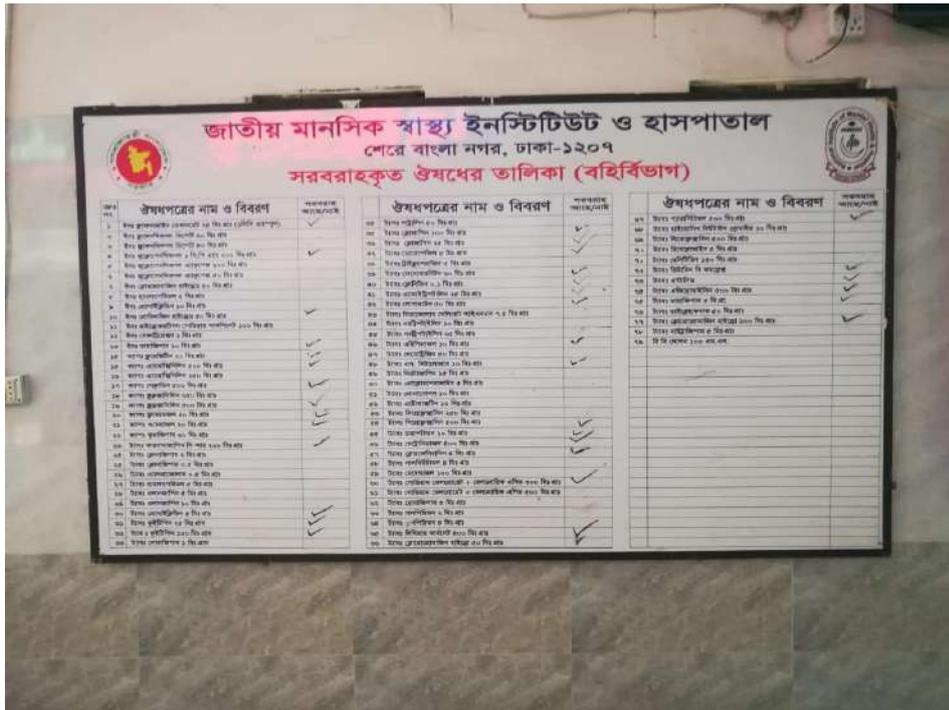
Pic-42: Inappropriate font size which is difficult to read for a person with low vision

Findings	Gaps	Recommendations
<p>There is a ticket counter cum dispensary with a height of 1194mm.</p> <p>There is enough space on the counter to allow privacy in communications.</p> <p>The information on the services at the health centre available in easy-to-read and large print format.</p> <p>The surface level, smooth and non-slippery.</p> <p>There is enough light so all the information can be seen.</p>	<p>There are no signs or pictographs at the reception that gives priority to people with disabilities, older people, adults with children, and pregnant women.</p> <p>There is no information/help desk in this area.</p> <p>There is no provision for sign language interpretation for patients who require it.</p> <p>There are no chairs available in the waiting area.</p> <p>Signages are abrupt and misleading.</p> <p>Inappropriate font size and color contrast used for the list of medicines board which is difficult to read for people with low vision, Pic-42.</p>	<p>Should have separate ticket counters and medicine counter. The ticket counter and medicine counter shall comply with section 3.4.1.5. Ticket counter, page 21.</p> <p>Create a priority service delivery system for people with disabilities, older people, and adults with children, and pregnant women. Create a priority lane with appropriate priority signs, an example shown in Pic-05, Annexure-1.</p> <p>Set up an information/help desk which shall comply with 3.4.1.4. Information Desk, page 19.</p> <p>Provide Sign Language Training to related staff such as Receptionists, and other medical and healthcare professionals.</p> <p>Set up a waiting area with enough sitting arrangement. Provision for reserve seats (with clear signage, Pic-06, Annexure-01) for people with disabilities, older people, and pregnant women. At least two wheelchairs reserve space; length 1100mm X width 750mm free space for one wheelchair (Fig-06, Annexure-02).</p> <p>Install appropriate signage.</p> <p>Use Capital Letters, Size: 60mm-100 mm. Characters should not be <i>italic</i>, highly decorative, or of other unusual forms, and a sans-serif typeface should be used. The surface of the board should be non-glare. Height within the field of vision preferably 1500mm above from the ground level.</p>

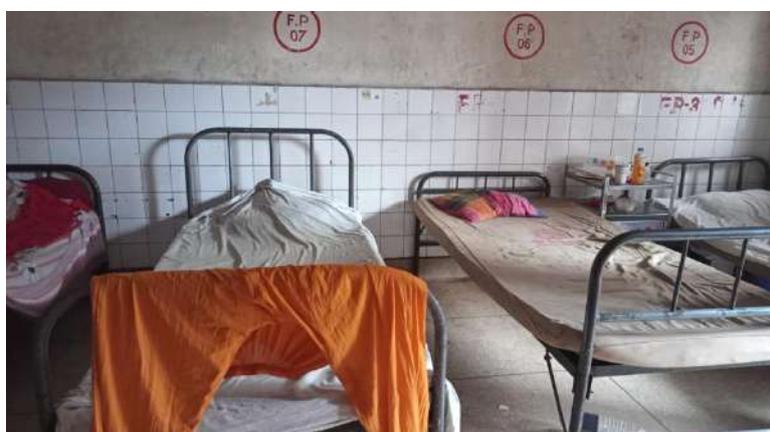
Pic-43: Insufficient space to move in between beds

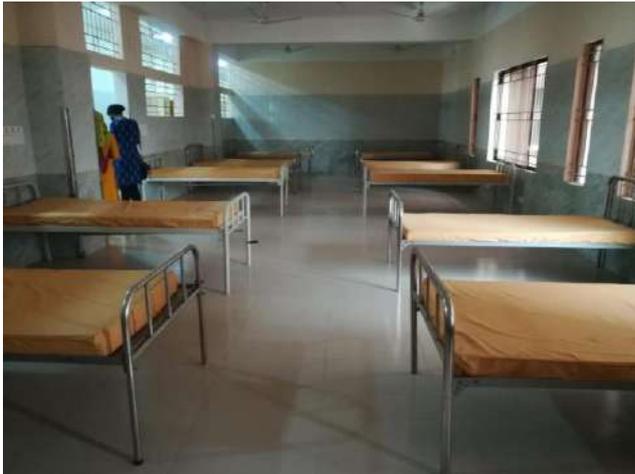
Pic-44: Well decorated male ward

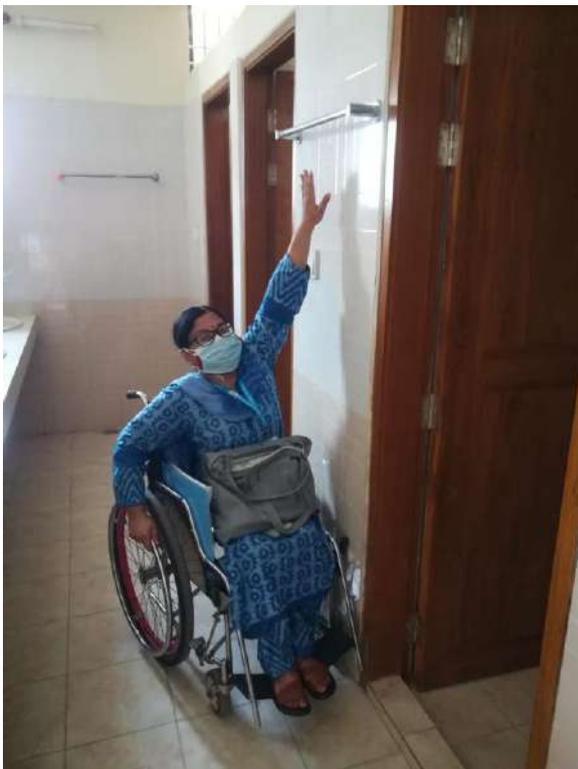
Pic-45: Towel rails are out of reach of a wheelchair user

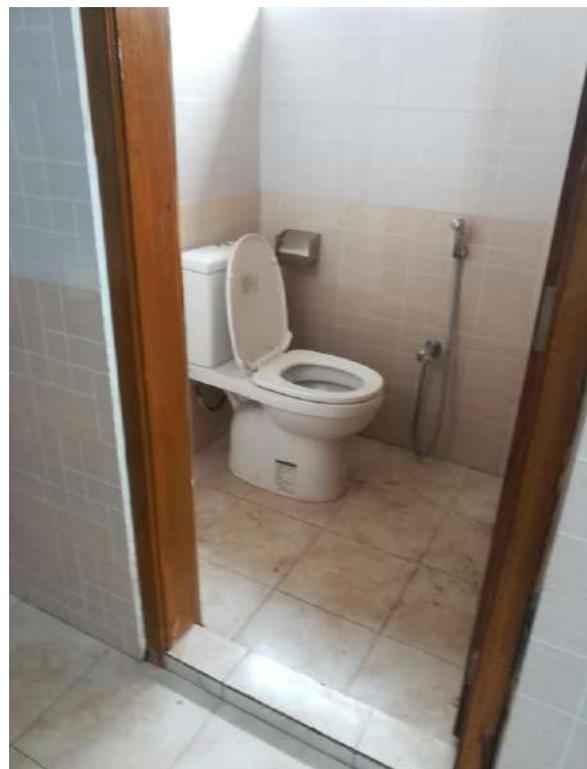
Pic-46: Threshold at the door of a toilet cubicle

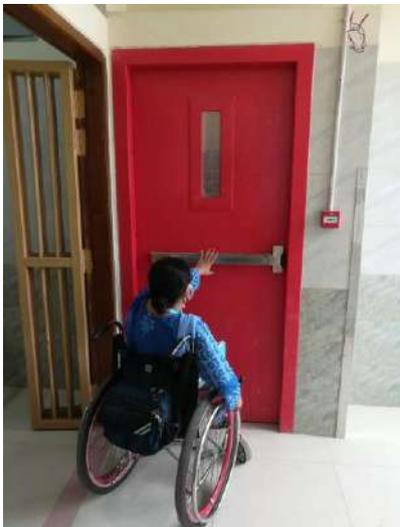
Pic-47: Fireproof Emergency exit door

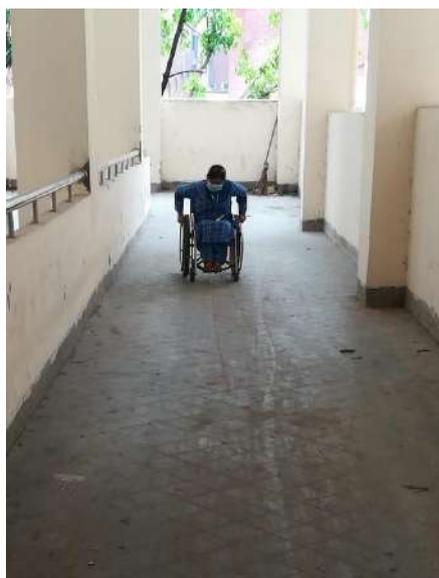
Pic-48: Inappropriate slope ratio of the ramp is difficult to climb a wheelchair user

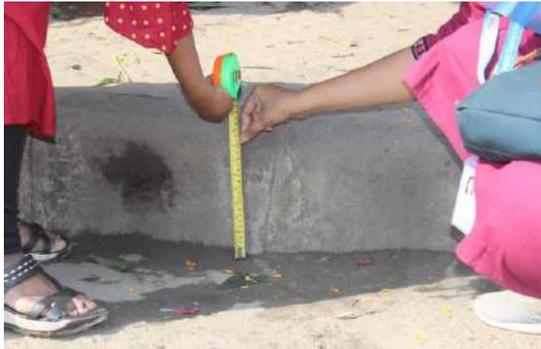
Pic-40: Footpath is too high

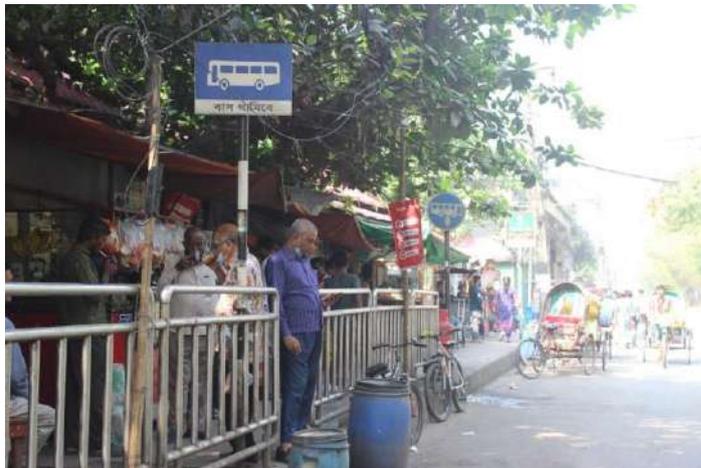
Findings	Gaps	Recommendations
	<p>are not visible clearly either, Pic-44.</p> <p>The lighting is insufficient to ensure the visibility and safety of pedestrians.</p> <p>There are no public toilets in this area.</p>	<p>page 47. Remove all obstructions from footpaths. The clear space shall be at least 1m to 1.25m.</p> <p>1.5. Signage: All accessible facilities including accessible parking, accessible routes, toilet, bus stoppage, road crossing, entry and other accessible services for the person with disabilities shall clearly display the symbol of access at the road front.</p> <p>A symbolized figure on a wheelchair and a contrasting plain square background shall be white on a blue background and always face to the right, shown as Pic-06. More details about signage are given in section 3.4.1.1. Outside of the hospital, pages 1-2.</p> <p>1.6. Continuous social awareness programs: Provide Training to traffic police may help to obey traffic signals pedestrians.</p> <p>An accessible pedestrian signal (APS) may help, it is a device that communicates information to pedestrians about the street crossing through audible tones and vibrotactile surfaces. Ensure sufficient lighting to ensure visibility and safety of pedestrians.</p> <p>1.7. Install road railing: Road rail shall be slip-resistance, free of sharp or abrasive gripping within a range of 850mm to 950mm from the floor.</p> <p>Shall have a continuous gripping surface with an appropriate colour contrast with the background.</p> <p>Diameter: 35mm – 50mm circular section</p> <p>1.8. Bus stoppage: Remove all obstructions from passengers waiting shall comply with section 3.4.1.8. Waiting area, page-16. The aisle for movement shall be not less than 1200mm.</p> <p>Add an accessible ticket counter shall comply with section 3.4.1.5. Ticket counter, page-11.</p> <p>1.9. Public toilet: Provide male and female separate public toilet facilities with at least one accessible toilet shall comply with section 3.4.1.11. Accessible toilet, page-34.</p> <p><i>(Bangladesh national building code, 2020)</i></p>

Pic-44: Signage placed too high, inappropriate colour contrast with the surroundings

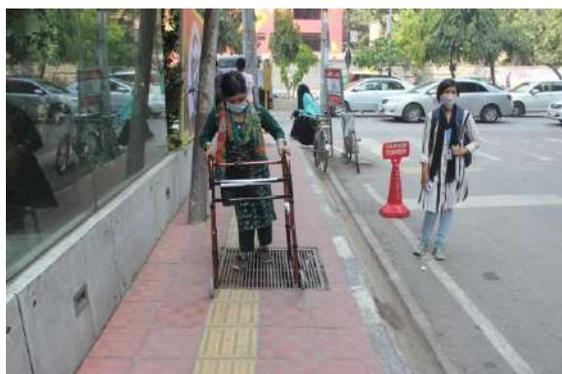
Pic-45: Grating in the middle of tactile indicator

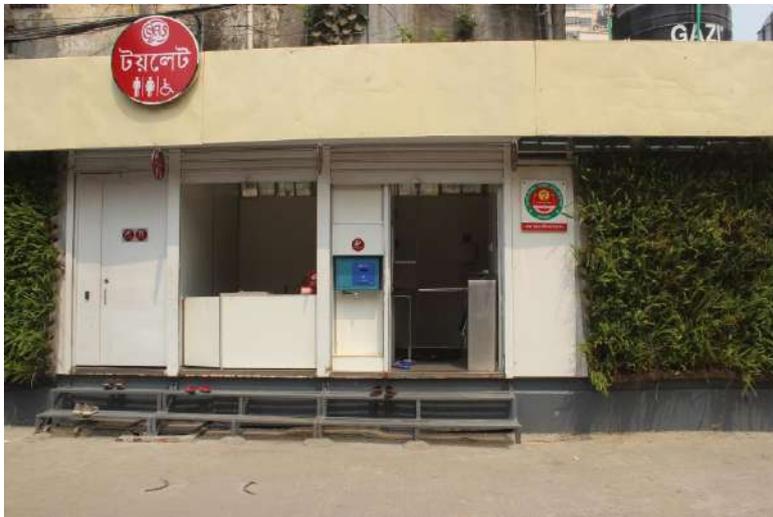
Pic-47: Toilet with inaccessible entrance

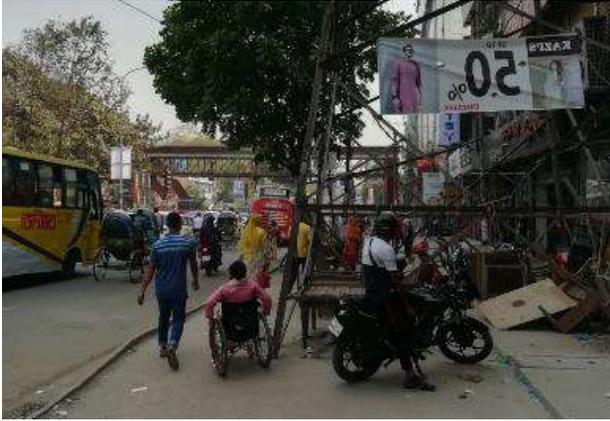
Findings	Gaps	Recommendations
<p>The height of the footpath is 254mm approximately. The footpath width is 4267mm but usable walking space is 1524mm due to obstructions. There is some signage placed 2260mm above ground level, Pic-04. Footpaths are being used by two-wheeled vehicles, causing obstruction and safety hazards to the pedestrians. There is one foot over bridge in this area.</p>	<p>There is no slope or landing from street level to footpath level. Changes in levels are not at all detectable since slopes and ramps are missing. The surfaces are broken, not tiled and not well-drained and non-slip, Pic-05. The pathway width does not meet with the standard of a one-way wheelchair clearance due to obstructions such as posts, stalls, tables, gas meters, wires, broken bricks, electric towers on the right side of the footpath, taking up almost half of the footpath space. In some cases, the walk able space is just 1524mm due to those obstructions, shown in Pic-01 & Pic-02. There is no directional tactile paving. The footpath is not tiled. There are no gratings. There are no curb ramps on footpaths on this side. There are no railings at the roadside of the pathway.</p> <p>There is no proper bus stand in this area. There are no public toilets in this area. There are no proper indications, signage, or pictographs on the roadside and no indications (zebra crossing) in case of nodes and road crossings. There is no proper signal control and traffic control in case of crossings, nodes and no provision for auditory alerts or proper signage for traffic control systems. Traffic signals are not obeyed by pedestrians in any case. The lighting is insufficient to ensure the visibility and safety of pedestrians.</p>	<p>1.1. Ramps are recommended at a street crossing, road islands, road dividers and entrance of any public buildings where height difference between levels are more than 150mm within the facilities. All of such ramps shall comply with section 3.2, page-5 of BSMMUH recommendations. Or, shall comply with Fig- 01; page 47.</p> <p>1.2 Curb ramps are recommended for level changes less than 150mm height shall comply with 1.2; page 42.</p> <p>1.3 Surface well-drained, Slip-resistance, have a detectable warning surface indicator and directional indicator with contrasting colors, shall comply with 1.2; page 42.</p> <p>1.4 Footpath wide shall comply with 1.4; page 42.</p> <p>1.5 Signage shall comply with section 3.4.1.1. Outside of the hospital, pages 1-2.</p> <p>1.6 Directional tactile paving shall comply with 1.3; page 42.</p> <p>1.7 Gratings shall comply with 2.3; page 49.</p> <p>1.8 Roadside railing shall comply with 1.7; page 43.</p> <p>1.9 Bus stoppage: should be accessible for the person with disabilities.</p> <ul style="list-style-type: none"> • Shall have a waiting area, sign and symbol, accessible routes. • Accessible parking area • Accessible ticket counter • Accessible toilet <p>1.10 Accessible traffic system shall comply with 1.6; page 43.</p> <p>1.11 Ensure sufficient lighting to improve visibility and safety of pedestrians.</p>

Pic-52: Obstacles on the footpath restricts movement

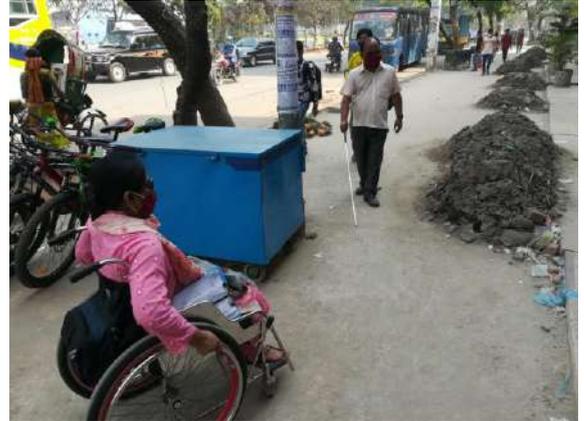
Pic-51: No tactile paving

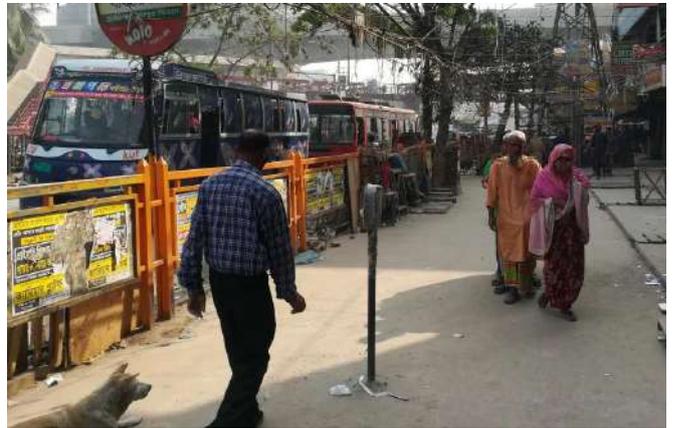
Pic-53: Signage is not placed within eyesight

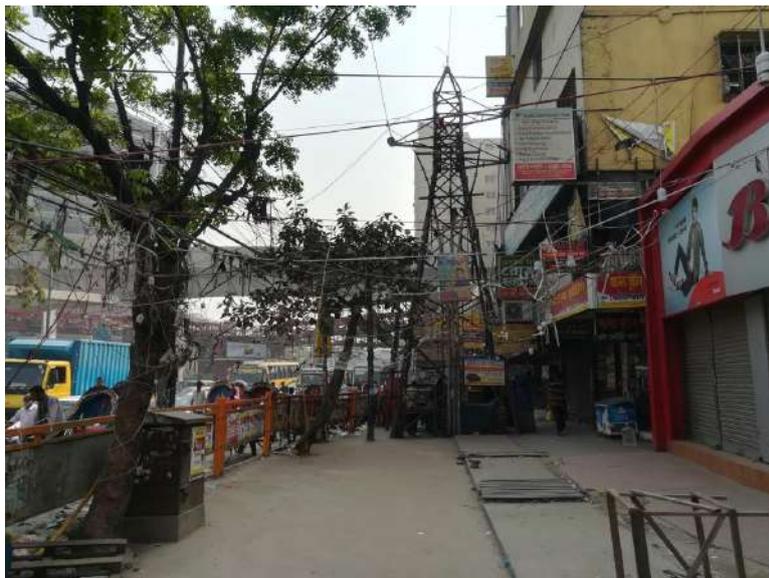
Pic-54: No curb ramp or slope in level changes

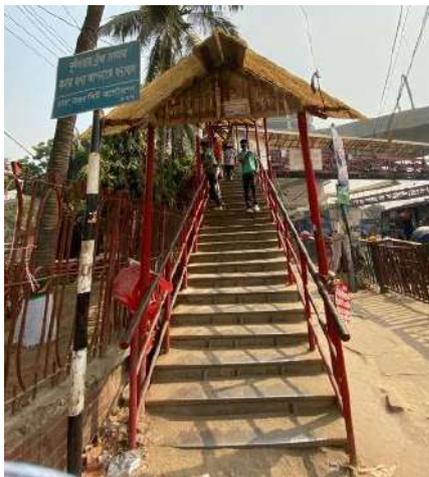
Pic-55: Handrail is not continuous and landings are missing

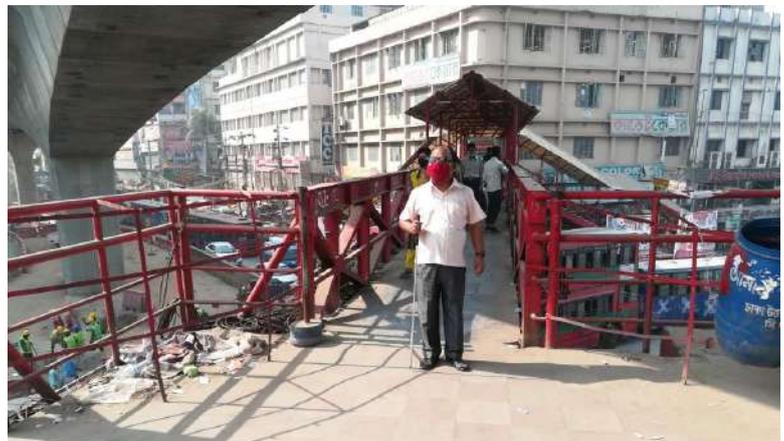
Pic-56: Tactile directional indicators are missing, floor materials are not appropriate as well

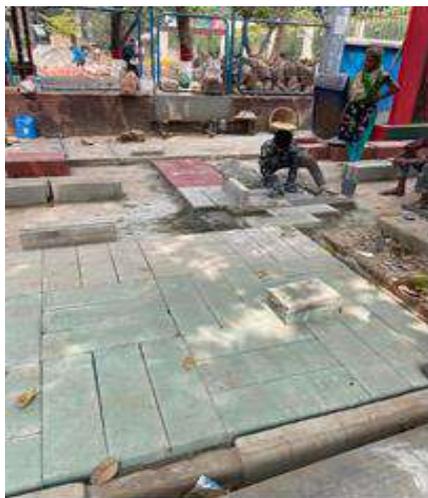
Pic-57: Footpath constructions ongoing

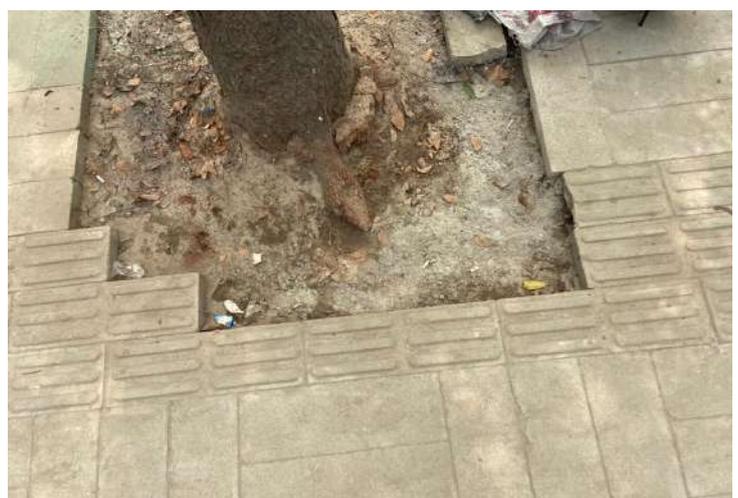
Pic-58: Tactile indicators interrupted due to street plantation

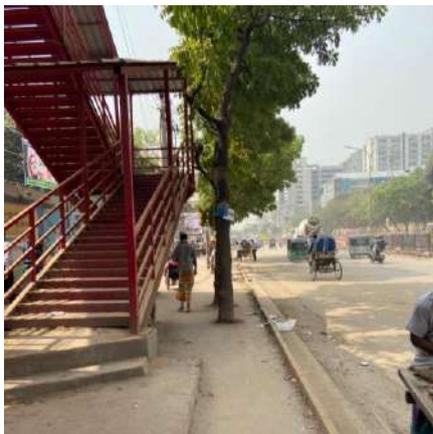
Findings	Gaps	Recommendations
<p>There is a Foot-over-bridge in the vicinity. There is an uneven pathway, broken towards the foot over bridge that measures 1066mm. Pic-59 There are 23 stairs and then mid-landing. The stair is dog-legged. Pic-60 On a single flight of stairs, the riser heights and tread widths are not uniform. Tread: 280mm or 264mm Riser: 100mm or 152mm There are no detectable warnings at the stairs. There is no nosing. The handrails are not continuous along both sides of the stairs. Gripping spaces are interrupted. Ends of handrails are not properly treated. Height of the handrails 1066mm The handrails are not circular. Mid-landing after 23 steps and 26 steps before the main landing. Mid-landing measures 3454mmx1600mm. The width of the stairway is 1500mm. There is no tactile ground surface indicator at every top and bottom of landings. There are light fixtures at every landing. There are no proper signage/ indicators for visually impaired individuals The staircase is prone to accumulating water The bridge circulation space is 2640mm. Ground coverings are not non-slip and well-drained</p>	<p>Stairs are uneven, broken and poor maintenance. The stairs are not properly constructed and can cause tripping. Handrails are interrupted by posts at intervals. Handrails are discontinued after the landing which may cause disruption. Even though there are 8-10 light fixtures on the foot over bridge, the lighting is insufficient for the nighttime. Huge crowd collision while climbing the stairs. The landings after 25 steps on a single flight can cause exhaustion and are not standard. The foot over bridge is not one way up” and one way down” and it is not possible to ensure this to avoid a severe collision.</p>	<p>4.1. Alter an accessible pathway shall comply with 2.1, page 62. 4.2. Stairs shall comply with section 3.4.1.3. Entrance - stairs, page-6. 4.3. Install appropriate signage shall comply with section 3.4.1.1. Outside of the hospital, page-6. 4.4. Ensure sufficient lighting on the over bridge.</p>

Pic-59: Foot over bridge do not have appropriate connecting routes
