Accessibility Audit of Footpaths and Public Hospitals in Dhaka (North and South) City Corporation Areas

Jan 2022

Prepared by

The Centre for Disability in Development (CDD)

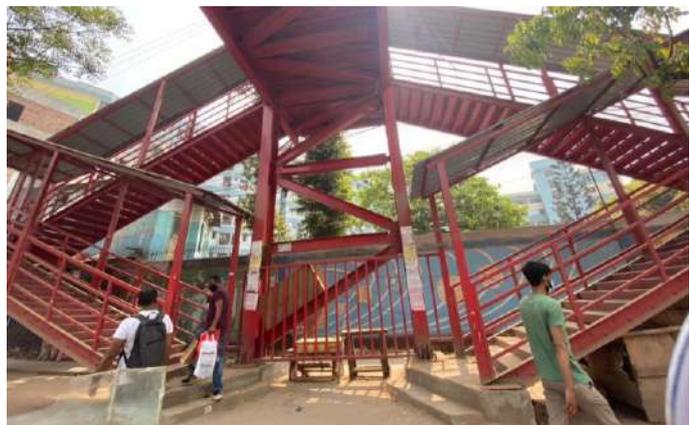
Pic-60: Initial steps are too high

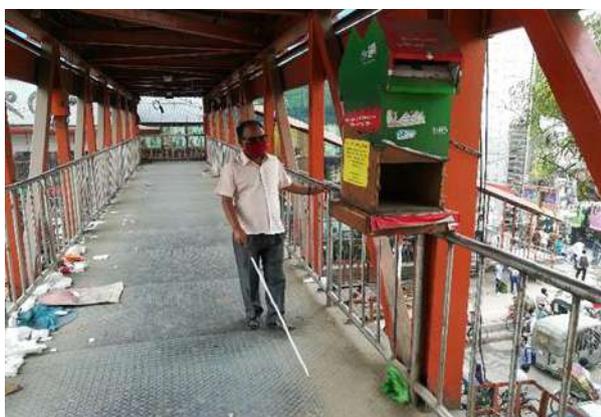
Pic-61: Obstruction on handrails

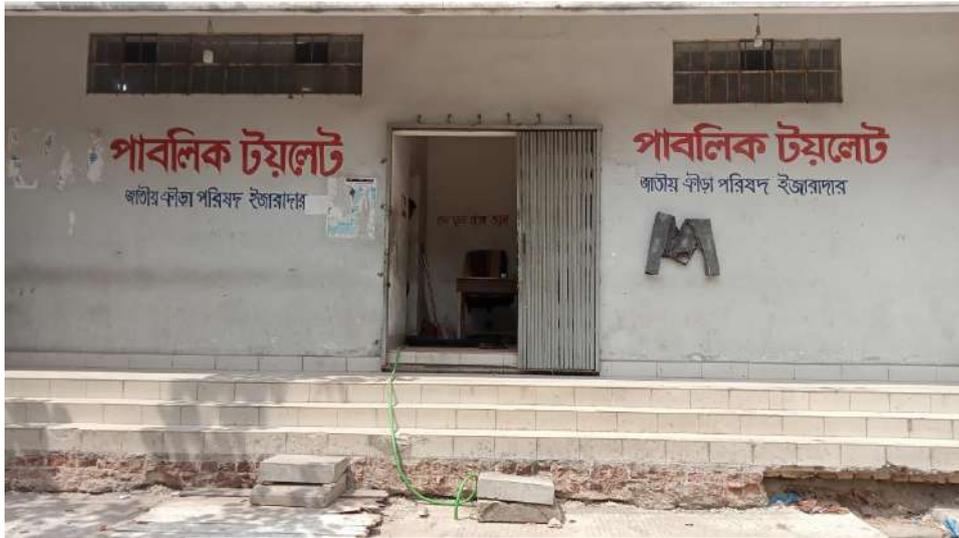
Pic-63: Entrance of public toilet is not accessible

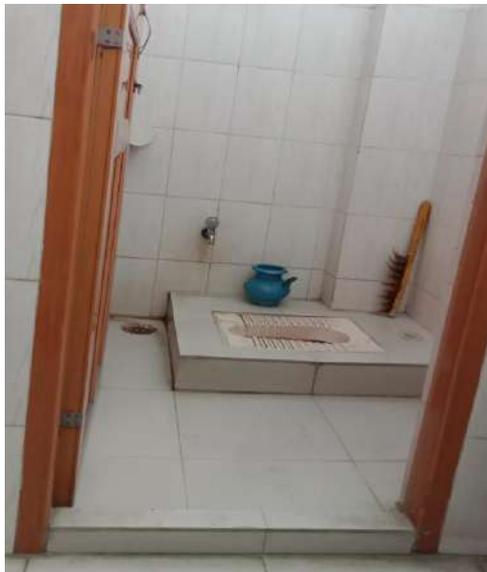
Pic-64: The door has a threshold that restricts a wheelchair

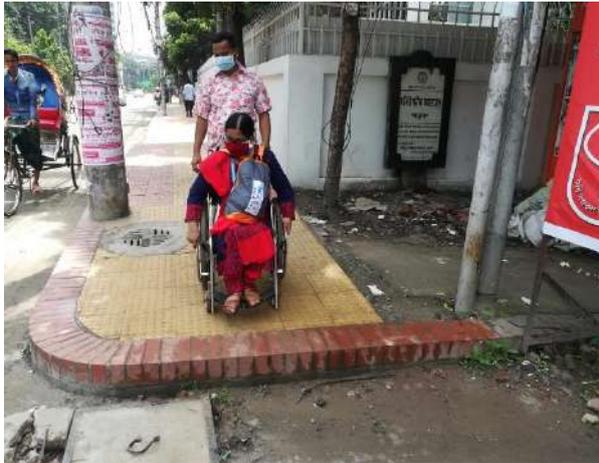
Pic-65: No slope or curb ramp

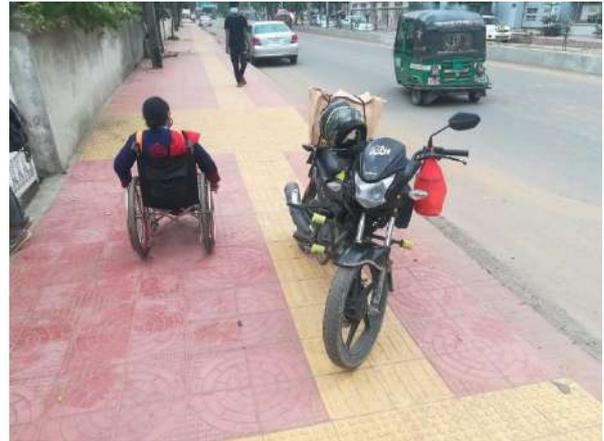
Pic-66: Vehicles parking on the footpath

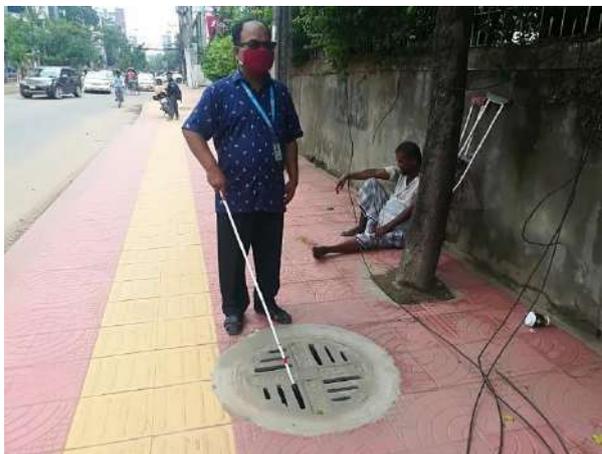
Pic-67: Wires and large grating

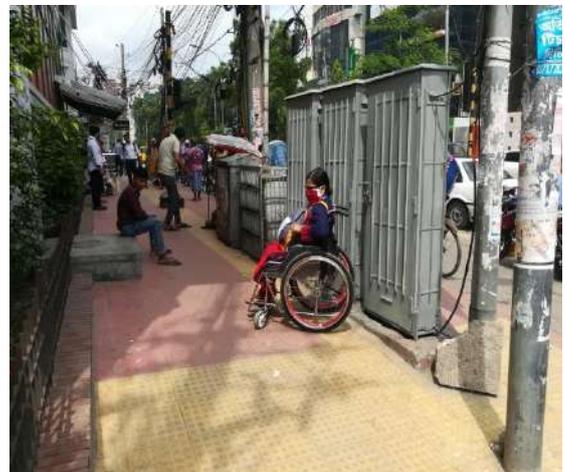
Pic-68: Obstacles on the footpath do not have any color contrast

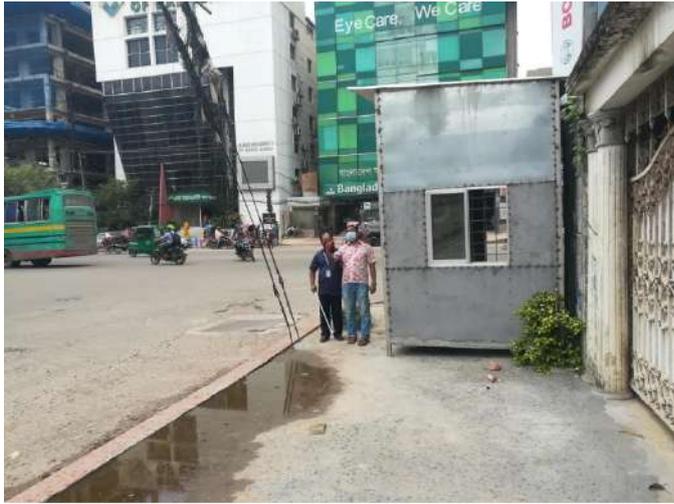
Pic-69: Police box on the footpath

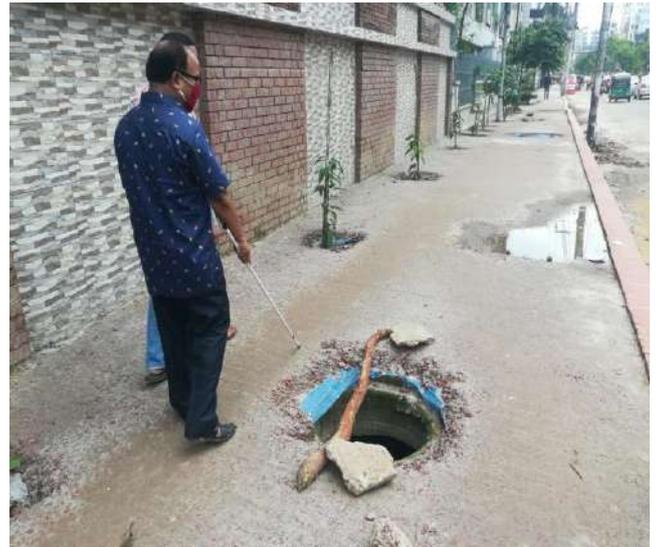
Pic-70: Manhole is not protected

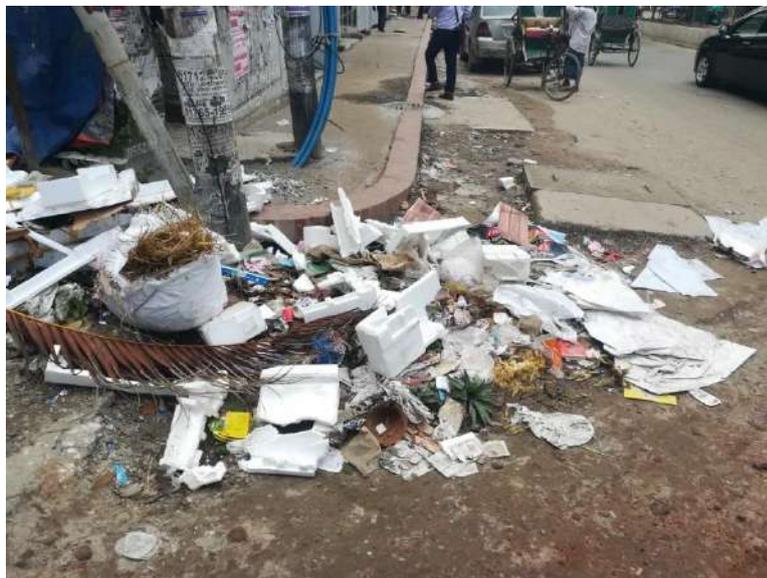
Pic-71: Dust and garbage block the entire footpath

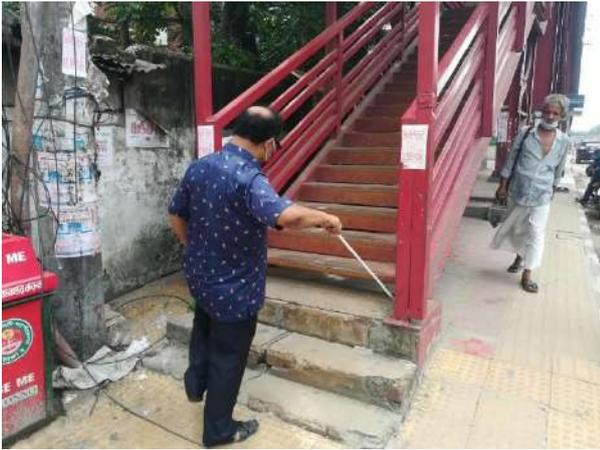
Pic-72: Stairs should be close risers

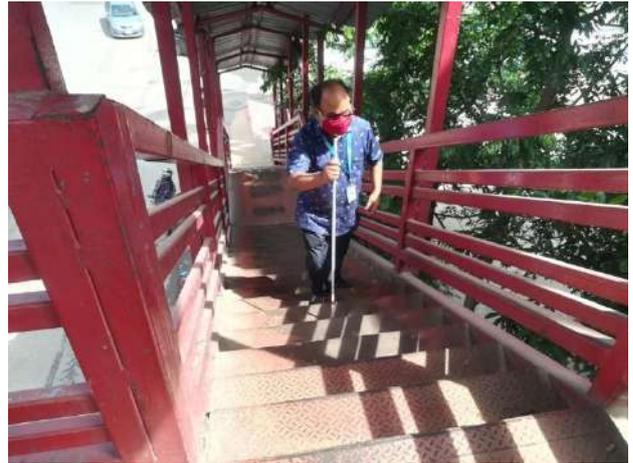
Pic-73: Foot over bridge do not have appropriate handrails

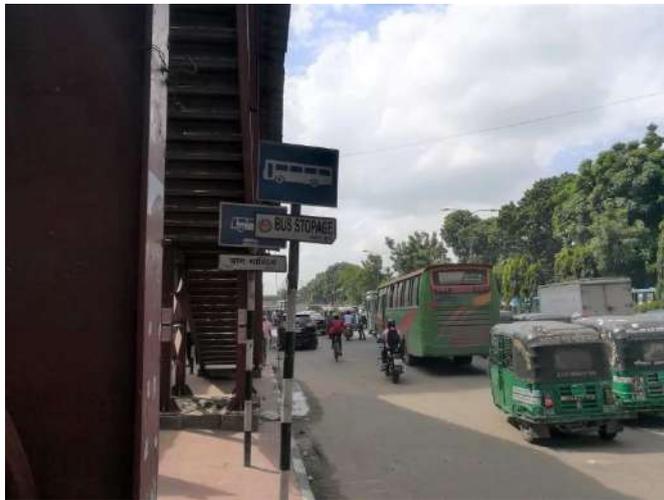
Pic-74: Signage of bus stoppage is at too high

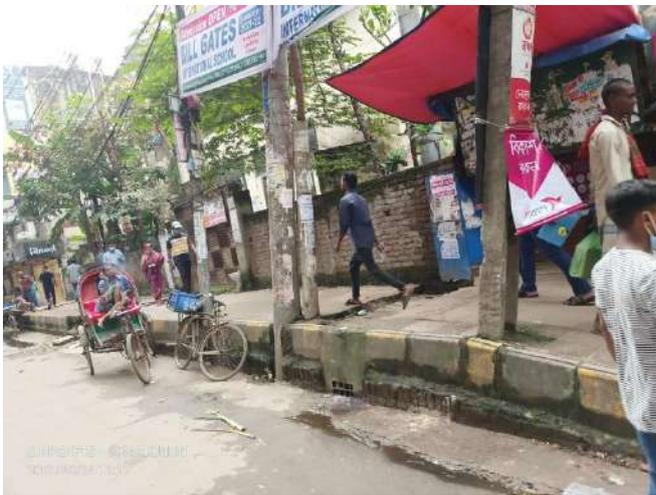
Pic-1: There is no slope or landing from street level

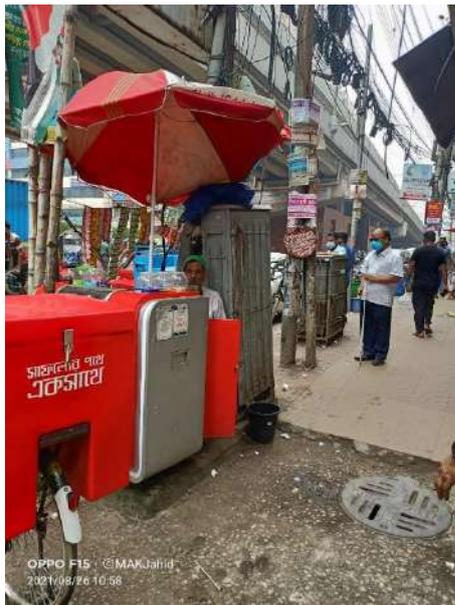
Pic-2: Vendors Shop, electric posts creating obstructions

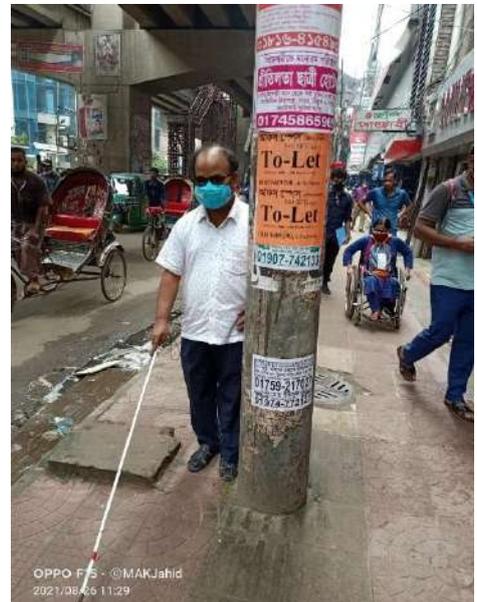
Pic-3: Tactile indicators are interrupted by the electric posts and manhole covers

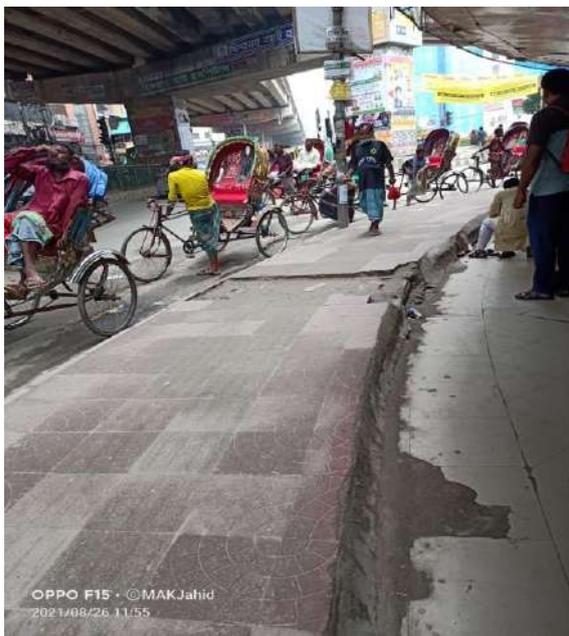
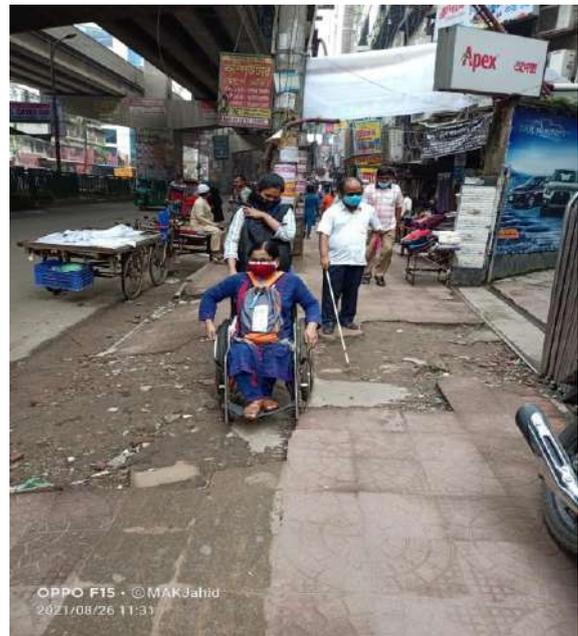
Pic-4 & pic-5: The continuation of the tactile around surface is absent

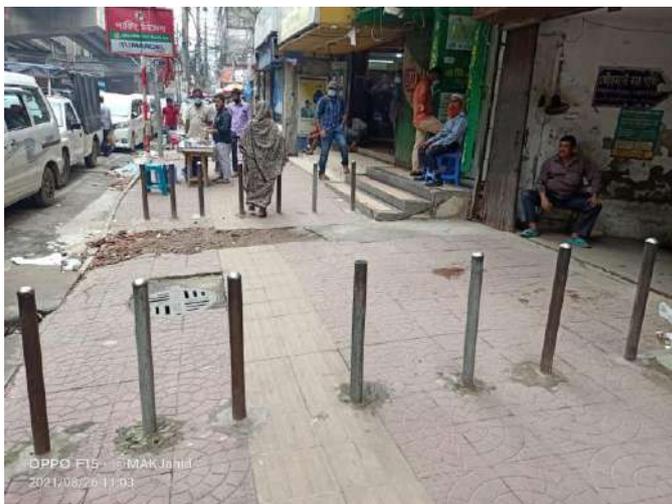
Pic-6: Footpath is blocked with post lead to pass wheelchairs impossible;

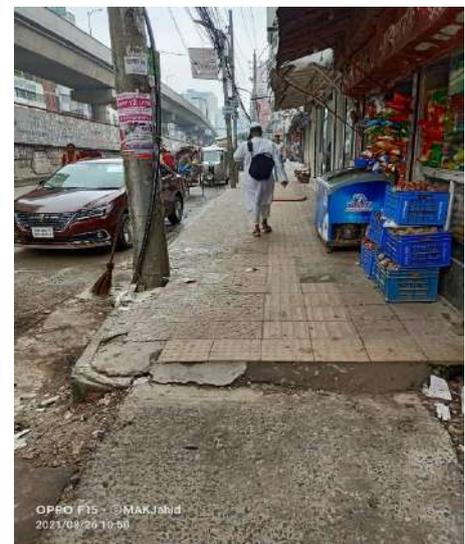
Pic-7: Curb ramp is missing in level changes;
