Accessibility Audit Report

Khulna BNSB Eye Hospital, Phultala, Khulna

Date of Assessment

October 10, 2021

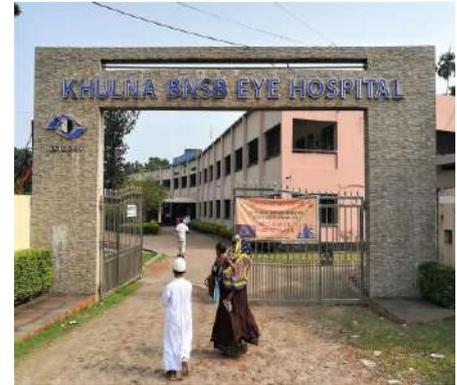
The hospital is located on the outskirts of Khulna town adjacent to the Khulna Jessore highway. The reputation of the hospital is acknowledged by the service recipients which helps patients and their caregivers to identify the hospital quickly. But there is no visible signpost marking 'Eye hospital ahead' at the intersection of the highway and the sub road of the hospital. However, there is a visible signpost on the main gate but no directional signage of the hospital found at the main gate.

Pic-1: No directional signage/information board at the main entrance gate

1) Appropriate color contrasted signboard at the main gate and directional signage throughout the hospital considering the following considerations mentioned below (points a-d).

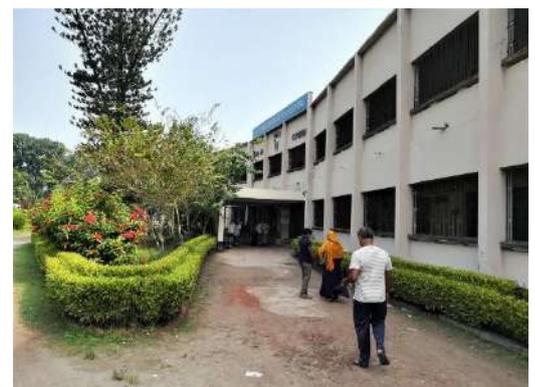
The pathway is wide enough, flat, concrete, non-slippery, obstacles, and hazards free for users of all abilities to move along to get to the main entrance of the building. However, no tactile ground surface indicators are present on the pathway leading to the entrance of the reception and main building (Pic-2).

Pic-2: Pathway does not have any tactile ground surface indicators

2) Installing tactile ground surface indicators on the pathway (pic-9).

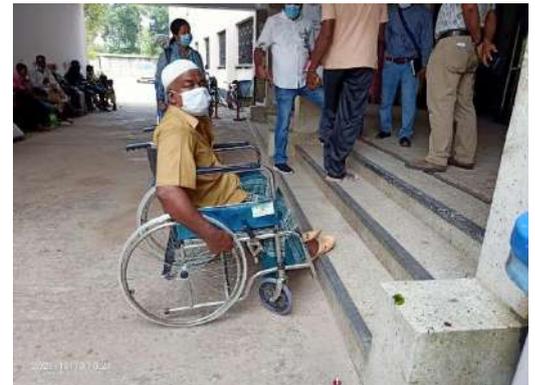
There is three entrance gate alongside the main entrance which have three steps to enter the hospital building. The width of each gate is 3480 mm wide. The height of each step/stair is 152 mm high and 305 mm deep. The pathway in front of the entrance is 4572 mm wide. The edge of the stairs is covered with metal which is in contrast in color with stairs. There is no ramp at the entrance. So that elderly person, persons with disabilities, pregnant women, etc. face difficulties during accessing eye care services (Pic-3).

Pic-3: No ramp at the entrances

3) A straight run ramp at the first entrance gate (Pic-10)

- A straight run ramp (minimum of 3480mmx2096mm platform along with a 5486mm long slope) is recommended at the first entrance gate (Annexure-1). The width of the slope will be 1524mm. Ensure the ramp has a maximum gradient of 1:12 ratio. The 1:12 gradient (Pic-10) will allow wheelchair users to propel their chairs independently on the ramp. The bottom landing of the ramp should be 2096mmx1524mm free space. This will allow the wheelchair user to full turns.

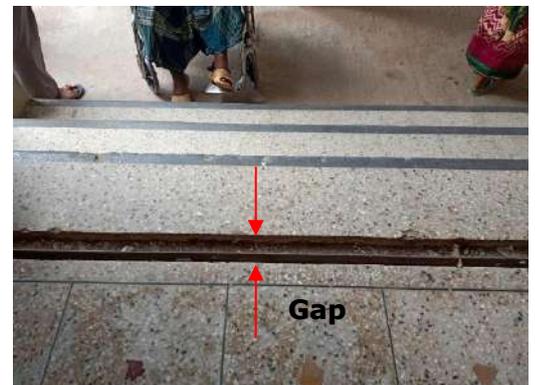
There are collapsible gates at each entrance which are open during the service hour. A gap of 76 mm between the floors is dangerous for everyone (Pic-4).

Pic-4: People can be injured by stumbling in the gap

5) Must use a temporary wooden slab (yellow color) for covering the gap during the collapsible gate is open. It will protect people's stumble.

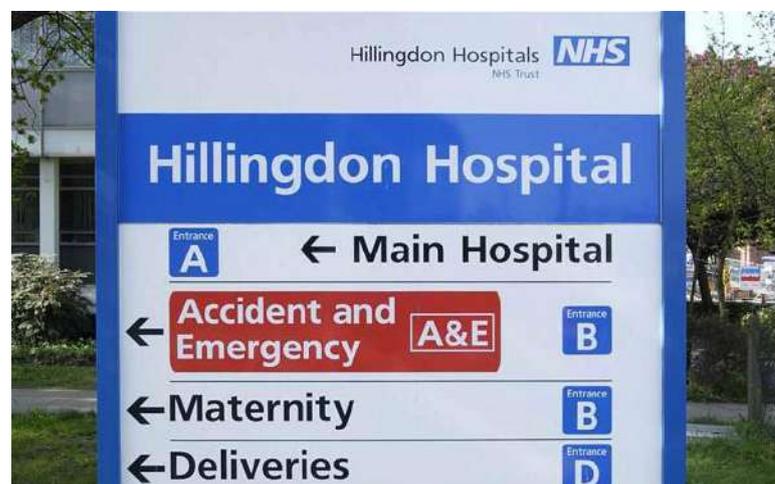
Pic-6

- a) The color of the characters should contrast with the background (Pic-6).
- b) Characters should not be *italic*, highly decorative or of other unusual forms, and a sans-serif typeface should be used.

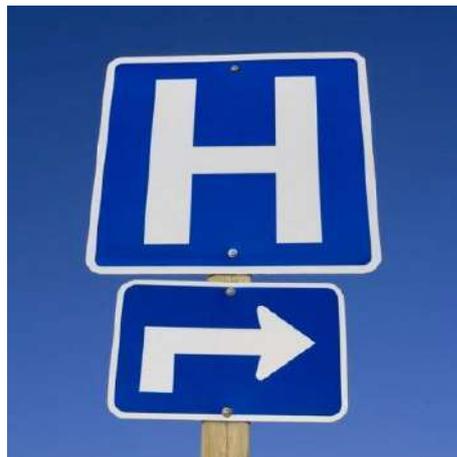
Pic-7

- c) The signage should include pictograms or other visual information (Pic-7)

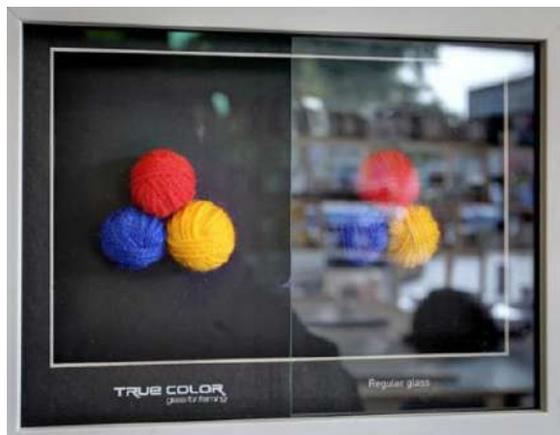
Pic-8

- d) The surface of the signage should be non-glare (Pic-8)

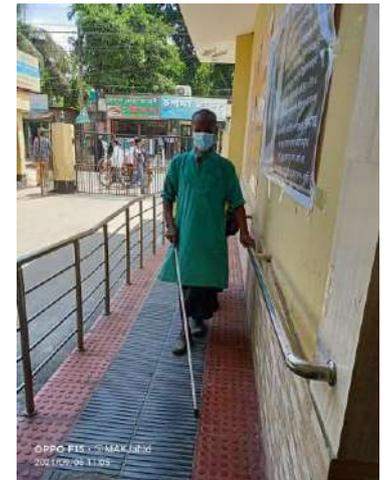
Pic-11: Tactile ground surface guides person with visual impaired

- On both sides of the ramp, there will be handrails with a height of 900mm and extend it to be beyond 300mm from the beginning of the ramp (Annexure-1).
- The shape of handrails should be circular to facilitate the grasp (diameter between 40 mm and 50 mm).
- The surface of the ramp should be non-slip and well-drained.
- There should be tactile ground surface indicators on the ramp and at the top and bottom landings for people with visual impairment (Pic-11).

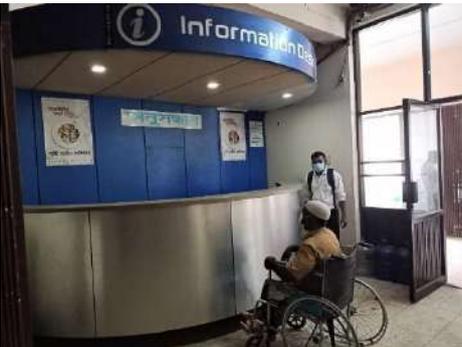
2.	<ul style="list-style-type: none"> ➤ The height of the information desk is 1219mm. There is no knee clearance for a wheelchair user who might face difficulties using the counter comfortably (Pic-13).

<p>Pic-13: Inappropriate height and lack of knee clearance is a problem for wheelchair users</p> <ul style="list-style-type: none"> ➤ The height of the ticket counter and billing counter is 1143mm and 1041mm respectively and there is no knee clearance for a wheelchair user except the billing counter. (Pic-14). 	<ul style="list-style-type: none"> ➤ Considering the limitations to renovating all the desks and counters accessible for all, it is highly recommended to set up a one-stop service desk/counter instead of the information desk. The one-stop service desk will be dedicated to providing services to persons with disabilities, older people, adults with children, pregnant women and injured person. <i>Ensure the front elevation of the reception counter would be straight instead of a curve shape.</i> ➤ The one-stop service desk will be accessible for the wheelchair user as the measurement considerations shown in Pic-15. The counter should have accessible height with knee clearance space.

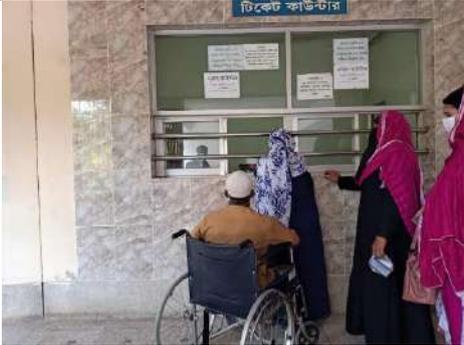
<p>Pic-14: Ticket counter is not wheelchair user friendly</p> <ul style="list-style-type: none"> ➤ As the ticket counter is on the side of the corridor, the service recipients have to stand in a queue in the corridor that interrupts movement on the corridor. 	<ul style="list-style-type: none"> ➤ Corridor must be free of all obstacles and hazards. It is recommended to shift the ticket counter to a suitable place to avoid the crowd on the corridors.

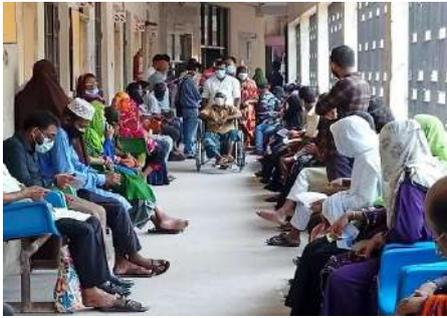
4.	<ul style="list-style-type: none"> ➤ There is no designated waiting area. However, there are chairs on both sides of the corridor where patients and caregivers sit. Inadequate space on the corridor restricts movement through the corridors (Pic-16).

<p>Pic-16: Inadequate space on the corridor restricts movement</p>	<ul style="list-style-type: none"> ➤ It is recommended to create a separate waiting area if possible. ➤ Waiting areas may equip with visual and acoustic calling systems. Appointment call announcements should be given both audibly and visually for the deaf, hard of hearing, blind, and partially sighted people (Pic-17).

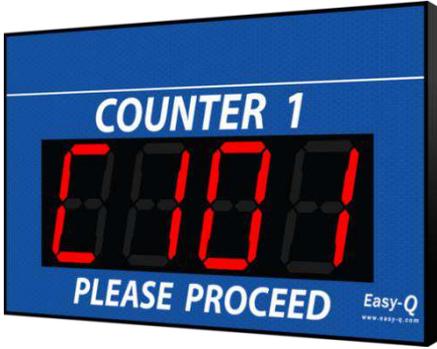
<p>Pic-17: Electronic display</p>

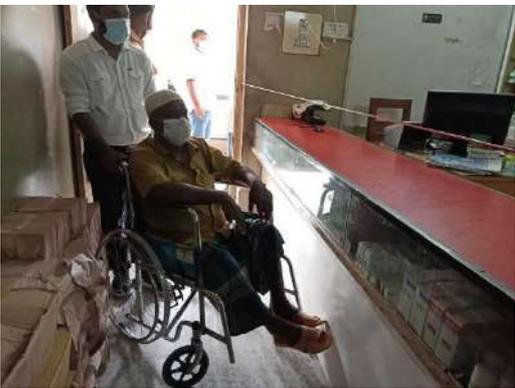
</div> <p>Pic-23: Narrow space inside the pharmacy restricts wheelchair full turns</p>

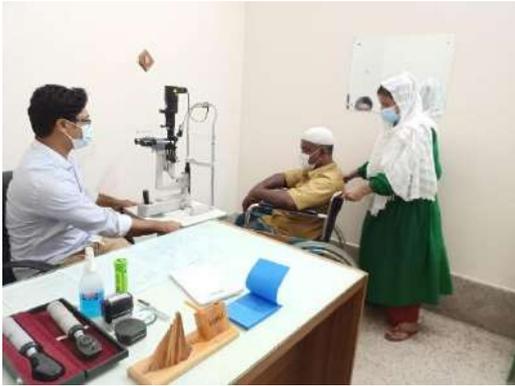
Dr. Room (Room-12)	
Findings	Recommendations
<ul style="list-style-type: none"> ➤ There is a total of five doctors room in the hospital. ➤ The features of both rooms are the same e.g. door width, door lock, room dimension, furniture, equipment, etc. ➤ The door lock is knob type (twist) and its height is 1067 mm. ➤ The door opens inward and is 864mm in width of each door. ➤ The room dimension is 4115 mm long and 3556 mm wide. ➤ The space inside the rooms is enough for a wheelchair user to full turns (Pic-24). <div style="text-align: center;">

</div> <p style="text-align: center;">Pic-24: Enough space inside the doctor's room</p> <ul style="list-style-type: none"> ➤ There are two wooden chairs inside the room near the slit-lamp which occupied the space in front of the slit-lamp. 	<ul style="list-style-type: none"> ➤ At least one Dr. room must be designated for persons with disabilities. This room is ideal for persons with disabilities. ➤ There should be signage of priority service (Pic-12, page 9) on the door that indicate giving priority service delivery for people with disabilities, older people, and pregnant women. ➤ The wooden chairs must be rearranged considering 1500mm diameter free space to maneuver a wheelchair to access services when the doctor will examine the eyes of the person using the slit-lamp. ➤ The use of pictorial signage on the door is more visible to the person who cannot read the signage (Pic-25). <div style="text-align: center;">

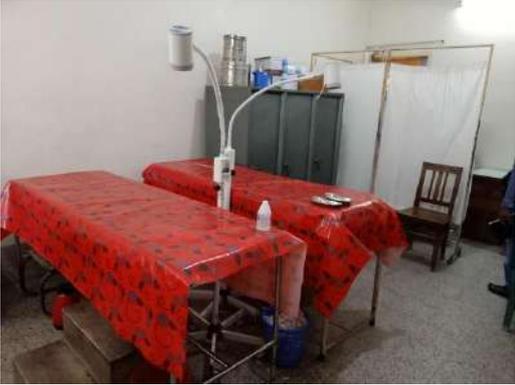
Dressing Room (Room-24)	
Findings	Recommendations
<ul style="list-style-type: none"> ➤ The door width is 864 mm and opens inward. ➤ The room has enough space but the partition near the entrance door creates obstacles for wheelchair maneuvering (Pic-27). ➤ Two dressing beds have a fixed height of 838mm which is too high for a wheelchair user for 	<ul style="list-style-type: none"> ➤ The partition must be reorganized to ensure adequate space for wheelchair users. ➤ Replace at least one wooden dressing bed with a height-adjustable bed (hydraulic). This will help a person who needs to transfer from wheelchair to bed.

<p>Pic-27: Fixed height wooden bed</p> <ul style="list-style-type: none"> ➤ The signage of 'Dressing Room' and room no. is written in Bangla in big font size and contrast in color which is visible to everyone but positioned above eye level which is difficult to mark many others. 	<ul style="list-style-type: none"> ➤ The ideal position of signage is 1524 mm from the floor. ➤ Disability Orientation training is needed for the staff for providing a better service to the patient.
Refraction Room (Room-29)	
Findings	Recommendations
<ul style="list-style-type: none"> ➤ The door opens inward. The door width is 762 mm which is acceptable for passing through and the inner space is wide enough for turning a wheelchair. ➤ The room dimension is 3581mm x 2565mm. ➤ This room has a lack of natural air ventilation. 	<ul style="list-style-type: none"> ➤ The ideal door width is 900 mm. It allows all types of wheelchair users to easily enter the room. ➤ Comparing with other this refraction room is ideal for persons with disabilities, aged persons, pregnant women, etc. ➤ Disability Orientation and Sign Language training is needed for the staff for providing a better service to the patient.

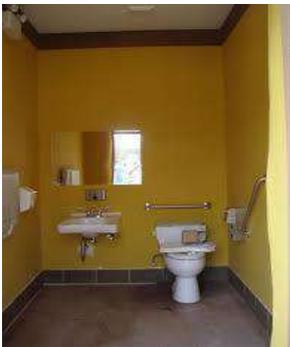
<p>Pic-29: Fittings are contrasted color with the background</p> <ul style="list-style-type: none"> ➤ The electric switchboards should be located within the range of 900mm to 1200mm above the floor finish.

<p>Pic-28: Washbasin without pedestal</p> <ul style="list-style-type: none"> ➤ The electric switchboards should be located within the range of 900mm to 1200mm above the floor finish.
VIP Cabin (AC)	
Findings	Recommendations
<ul style="list-style-type: none"> ➤ There is two AC cabin. ➤ The door has 864 mm clear width and opens inward. ➤ There is two bed in the cabin. One is height adjustable and another one is fixed height. ➤ The fixed bed height is 635 mm (including mattress). ➤ The distance between the two beds is 1600mm which is enough for wheelchair movement. ➤ There is an attached toilet which dimension is 1727mm X 1600mm and the door width is 635mm, door opens inward which is narrow for a wheelchair user. ➤ The toilet floor is 114 mm higher than the cabin floor. ➤ There is a high commode and a pedestal washbasin inside the toilet. ➤ Commode, washbasin, and fittings are not contrasted color with the background. ➤ The electric switchboard height is 1448mm high from the floor. 	<ul style="list-style-type: none"> ➤ At least one AC cabin should be accessible and allocated for persons with disabilities. ➤ A renovation is needed to make the toilet accessible for wheelchair users. ➤ The toilet floor must be on the same level as the cabin floor. ➤ It is recommended to replace the existing toilet door with a sliding door. At least a 762 mm clear opening will be needed. ➤ All the fittings for inside the toilet should be in contrast color with background (Pic-29).

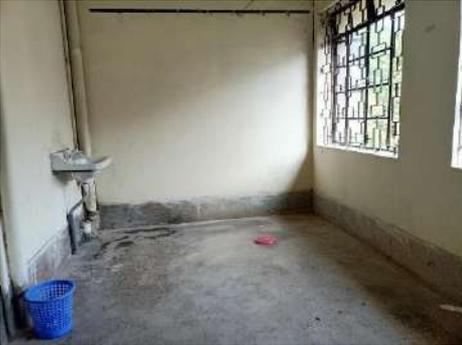
Paying bed (Male), & Toilet	
Findings	Recommendations
<ul style="list-style-type: none"> ➤ The room has a fixed height of four beds. But no particular bed for the person with disabilities. ➤ The beds were not marked with any numbers. ➤ The room has two doors. One is for entering the room and the other one is for going to the toilet. Each door is 889mm wide which is convenient for wheelchair users. ➤ The front door lock is a knob lock type which height is 1016mm. ➤ There are three toilets beside the paying bed. Among them, no one is accessible for all. ➤ There is a space beside the toilet block which dimension is 2743mm x 2134mm (Pic-30). <div style="text-align: center; margin-top: 10px;">

</div> <p style="text-align: center; margin-top: 5px;">Pic-30: Unused space beside the toilet block</p>	<ul style="list-style-type: none"> ➤ Accessible bed height should be between 508mm to 635mm including the mattress. ➤ A hydraulic bed should be reserved for patients with disabilities. ➤ Each bed should be marked with a serial number. ➤ Lever handle door lock is recommended to use for all doors (Pic-31). <div style="text-align: center; margin-top: 10px;">

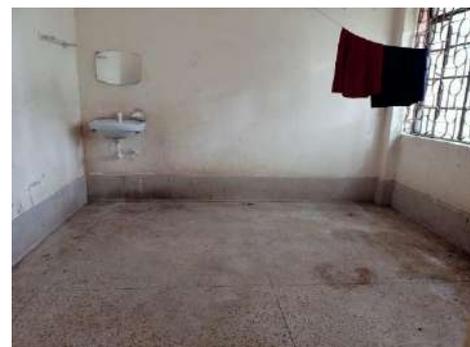
- Each bed should be marked with a serial number.
- Ensure appropriate fluorescent lighting (200-750 lux), without glare or shadows.
- **Accessible Toilet for male ward:**
 - There is a toilet in the right corner of the mail ward that can be converted into an accessible toilet. For this civil work is needed.
 - Ensure proper door width, fittings, high commode, signage, etc. for the toilet. The measurement and features of an accessible toilet are described on page no. 29,30,31.
 - As the toilet floor is higher than the ward floor, a 1:12 ratio ramp will be needed in front of the toilet chamber.
 - A sliding door is recommended instead of the existing door.
- **Accessible Toilet for female ward:**
 - The unused space beside the toilet block can be used to make an accessible toilet.

Pic-32: Unused space can be used to build an accessible toilet

<ul style="list-style-type: none"> ▪ The existing dimension (3556mm x 2007mm) is enough to build such a toilet. For this civil work is needed. ▪ Ensure proper door width, fittings, high commode, signage, etc. for the toilet. The measurement and features of an accessible toilet are described on page no. 29,30,31??. <p>➤ Nametag and pictorial signage should be positioned at 1524 mm from the floor. Please refer to recommendation-1 on page-6 & 7 for the considerations of accessible signage.</p> <div style="text-align: center;">

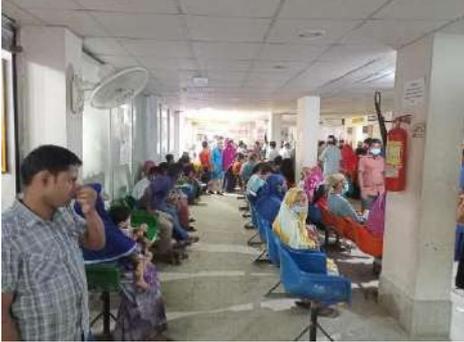
Waiting Area (Ground floor)	
Findings	Recommendations
<ul style="list-style-type: none"> ➤ The waiting area in front of room no. 21 is spacious but crowded. The floor surface is level, smooth, and non-slippery. ➤ There are sufficient chairs contrasted in colors but no priority seating for elderly people, pregnant women, and persons with disabilities (Pic-34). 	<ul style="list-style-type: none"> ➤ Signage of reserved seats (Pic-18, page 12) for people with disabilities, older people, and pregnant women must be posted in the right place on the wall. ➤ At least two wheelchairs reserve space; length 1100mm X width 750mm free space for one wheelchair (Pic-19). A clear Wheelchair accessible mark on the reserved floor space is also necessary (Pic-20). ➤ Ensure sufficient lighting in the waiting area. ➤ For ease of reach, the electric switchboards should be located

<p>Pic-34: No priority seating</p> <ul style="list-style-type: none"> ➤ There is no sufficient natural and artificial lighting in the waiting area. 	<p>within the range of 900mm to 1200mm above floor finish.</p> <ul style="list-style-type: none"> ➤ For switches (dark switch and socket plates) should be used for light backgrounds or vice versa.
--	---

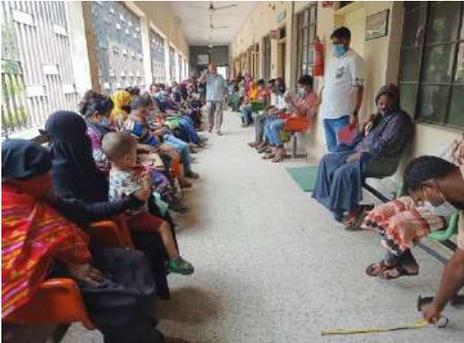
Corridors	
Findings	Recommendations
<ul style="list-style-type: none"> ➤ All corridors are wide, level, smooth, and non-slippery. ➤ The corridor is crowded with patients and their attendants.

<p>Pic-35: The corridor is overcrowded</p> <ul style="list-style-type: none"> ➤ The way of natural air ventilation is Okay. ➤ No priority seating for elderly people, pregnant women, and persons with disabilities. ➤ There was no directional signage in the corridor to assist people to go specific places. ➤ No wastebasket was on the corridors. 	<ul style="list-style-type: none"> ➤ Signage of reserved seats (Pic-18) for people with disabilities, older people, and pregnant women must be posted in the right place on the wall. ➤ At least two wheelchairs reserve space; length 1100mm X width 750mm free space for one wheelchair (Pic-19, page no. 12). A clear Wheelchair accessible mark on the wall is also necessary (Pic-20, page no. 12). ➤ Directional signage should be put in place for easy movement of the service recipients. Appropriate signage of the related facility is shown in Pic-36.

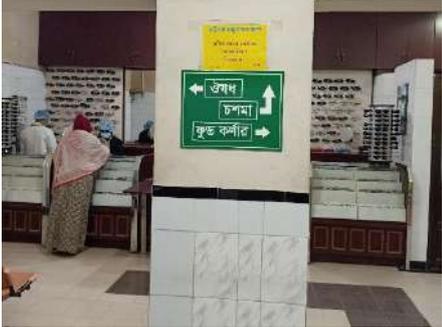
<p>Pic-36: Directional signage helps a person to reach the destination</p> <ul style="list-style-type: none"> ➤ Ensure an adequate number of wastebaskets in the corridors to maintain hygiene.
--	---

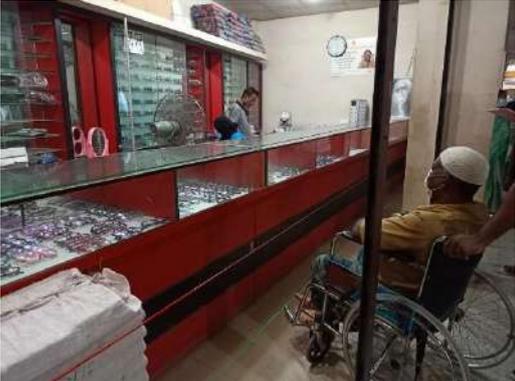
Optics shop	
Findings	Recommendations
<ul style="list-style-type: none"> ➤ The floor space in front of the Optics area is wide enough and free of hazards and obstacles. ➤ The counter height is 1067mm. ➤ The height of the counter is not convenient for wheelchair users even the counter has no knee clearance.

<p>Pic-37: The counter is not accessible for all</p> <ul style="list-style-type: none"> ➤ There is no sign at the counter that gives priority to persons with disabilities, older people, and adults with children, and pregnant women. 	<ul style="list-style-type: none"> ➤ At least one counter should accommodate a wheelchair user as the measurement considerations shown in Pic-15, page no. 10. The counter should have an accessible height (minimum 762 mm) with knee clearance space and be marked with an international symbol of accessibility (Pic-20, page no. 12). ➤ There should be signage of priority (Pic-12, page no. 9) lane at the Optics shop that indicates giving priority service delivery for people with disabilities, older people, and pregnant women. ➤ Provide disability orientation and Basic Bangla Sign Language training to the related staff.

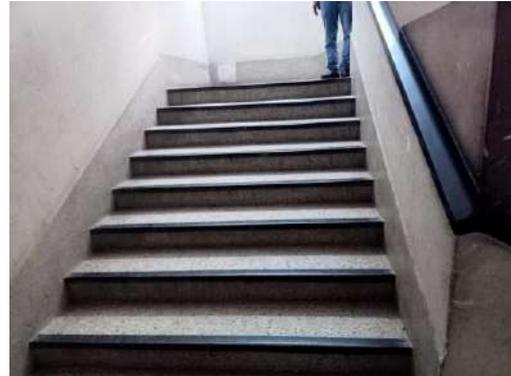
The measurements of staircases e.g. width (1626mm wide), tread, riser are okay considering the universal design standard. There are no handrails except one side concrete railing which height and gripping space are not good for grasping. However, the edge of the stairs is covered with metal which is in contrast in color with stairs.

Pic-38: No handrails on the stairs

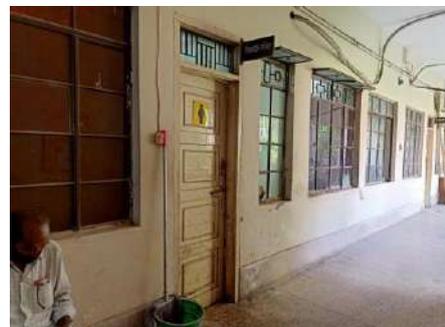
- There are toilets in two different areas on the ground floor.
- None of them are accessible for all e.g. narrow door width and room dimensions, the door opens inward, low commode, inappropriate fittings, etc.
- There is a separate toilet for 'Male' & 'Female' next to room no. 11.
- There are signages of 'Male' & 'Female' posted on each toilet door.
- No grab rails in the toilet.
- No sanitary bin is available.

Pic-39: Narrow door width restricts wheelchair

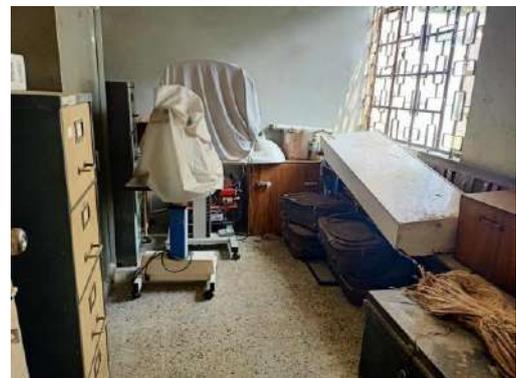
It is highly recommended to build at least one accessible toilet on the ground floor and for other floors including ward in separated male and female signage. There is a store room next to room no. 11. This room can be converted to an accessible toilet for the ground floor. The existing dimension is enough to build a such toilet. And this will require civil works.

1. The existing room dimension is 3531mm x 2896mm which is bigger than the ideal room dimension of an accessible toilet.
2. The door has a threshold and must be removed for wheelchair access.
3. Clear directional signage indicating the location of the toilet/accessible toilet.
4. The door should have-
 - a) Clear opening width of 900mm;
 - b) A clear space on both sides of the door that allows a wheelchair to approach the door and open it;

Pic-40: Proposed space for accessible toilet

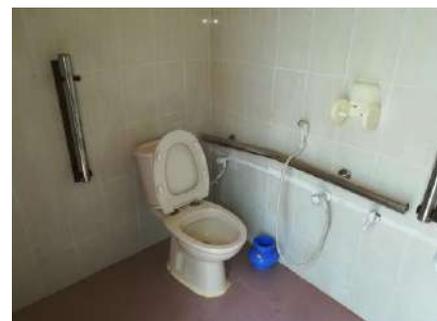
Pic-41: Grab bars

- 8. Two fixed horizontal grab rails**—one grab rail should be on the wall of the non-transfer side of the toilet pan fixed firmly at a height of approximately 700mm and projecting 100mm over the front edge of the toilet pan. Similarly, at the same height, another folding grab rail should be mounted at the back wall of the toilet pan (Pic-41).

- 9. Size and spacing of grab bars and handrails**—the diameter or width of the gripping surfaces of a handrail or grab bar shall be 32 mm to 38 mm, or the shape shall provide an equivalent gripping surface. If handrails or grab bars are mounted adjacent to a wall, the space between the wall and the grab bar shall be 38 mm.

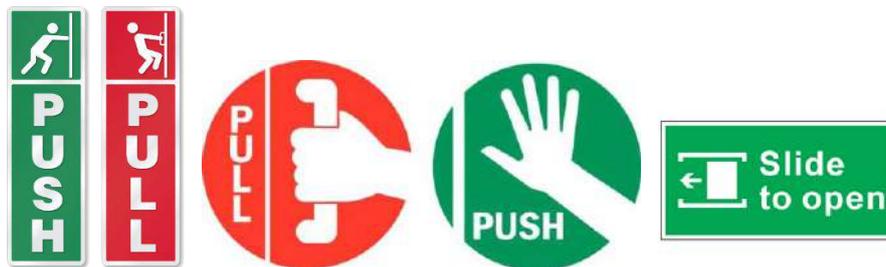
Pic-46: Signage

Accessible fire exit

- Emergency exit facilities should be available and contain clear signage indicating accessible escape routes (Pic-46).
- The ramp may use for an emergency exit. As such all discard items should be removed from the ramp and the collapsible gate must be always open.
- On both sides of the ramp, there will be handrails with a height of 900mm.
- It's useful to have visual information in both Bangla and English versions explaining how to maneuver the door.

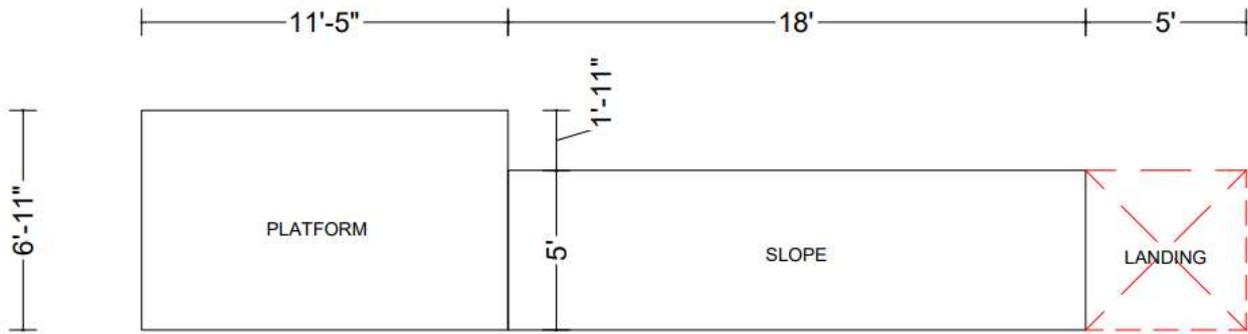
WORKING DRAWING OF RAMP: PLAN

Plan and elevation of the Ramp:
