Accessibility Audit of Footpaths and Public Hospitals in Dhaka (North and South) City Corporation Areas

Jan 2022

Prepared by

The Centre for Disability in Development (CDD)

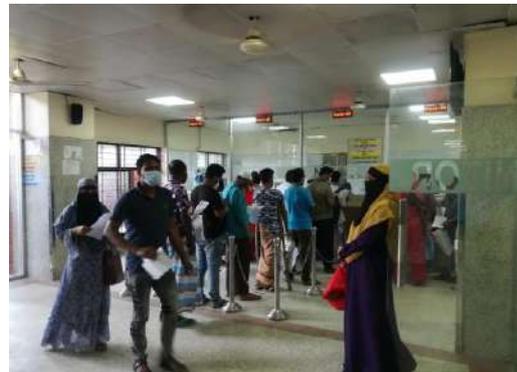
Pic-17: No reserved booth for persons with disability, senior citizens were seen in the Ticket & cash counter

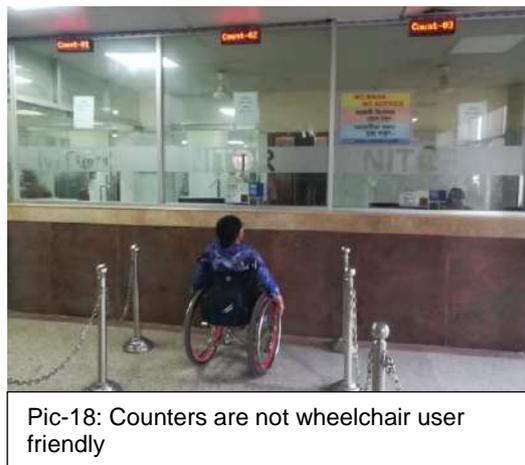
Pic-18: Counters are not wheelchair user friendly

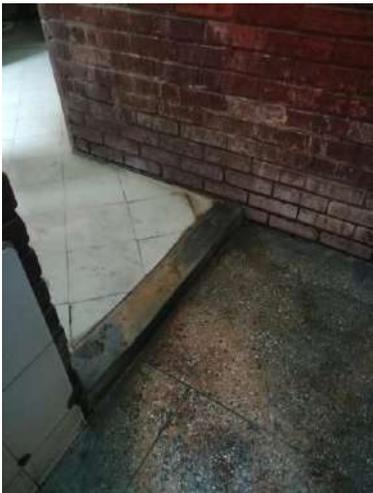
The total numbers of beds are 42. There is 1219mm space in between beds. All beds are height adjustable. There is an attached toilet facility in each ward. Every toilet block there are four toilet cubicles and four bathing facilities. The main door of the toilet block is 838mm wide, Pic-26. Toilet cubicles door width 610mm and have a 102mm high threshold, Pic-27. Each cubicle is 1219mm×1524mm in dimension. There are four low commodes at each toilet block. Water taps heights are 305mm from the floor level. There is a storage space for stretchers and wheelchairs.

Pic-26: Threshold at the toilet entrance inside general ward

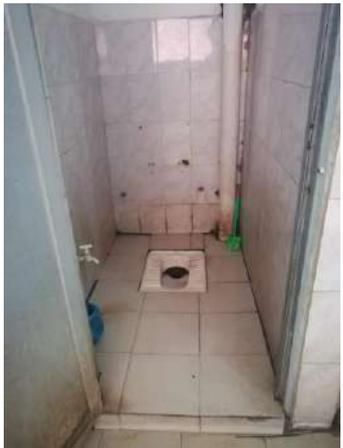
Pic-27: Toilet cubicle inside the general ward

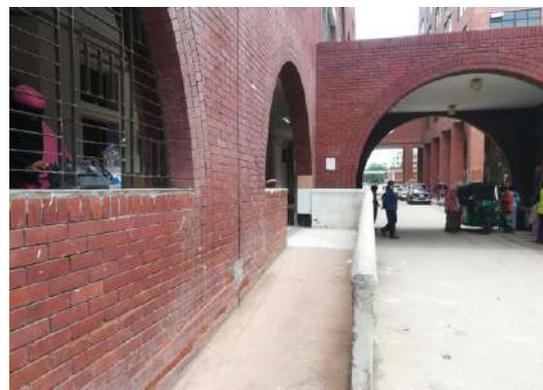
Pic-31: Ramp at emergency entrance

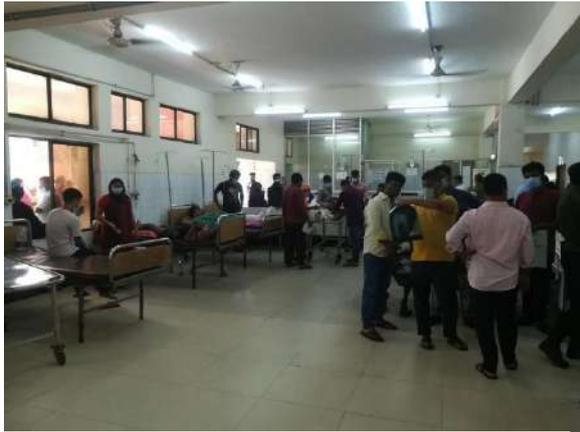
Pic-32: Inside the emergency unit is overcrowded

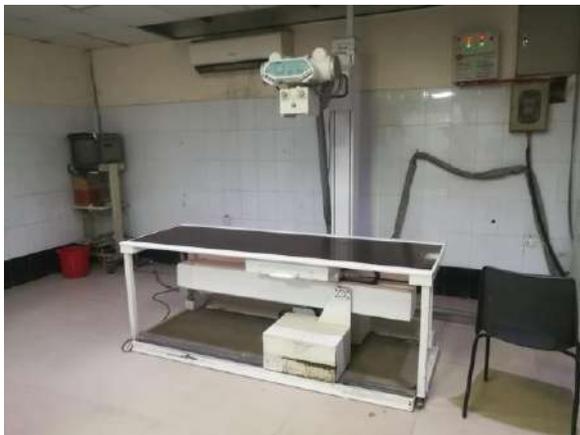
Pic-34: X-ray table is not accessible

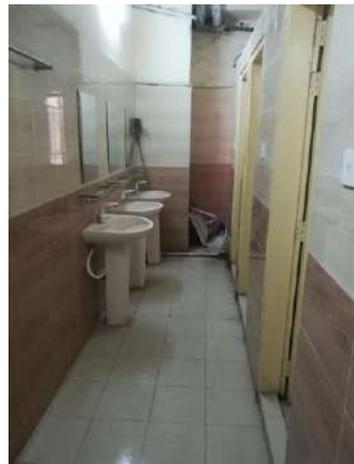
Pic-36: Pathology toilet block not accessible for persons using wheelchair

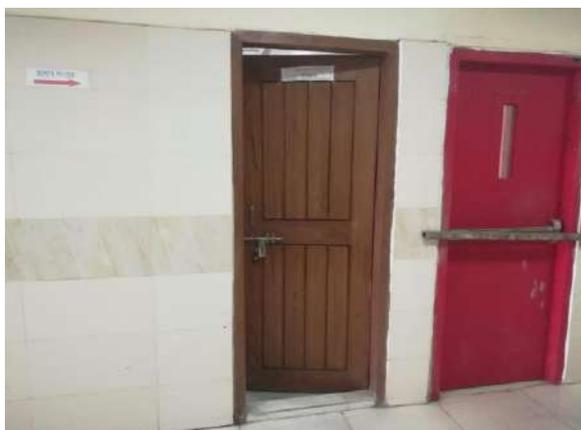
Pic-37: No clear signage at toilet door

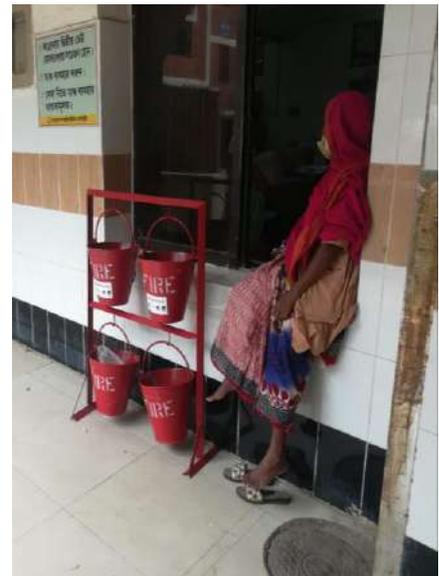
Findings	Gaps	Recommendations
<p>There are no fire exit routes. There are fire extinguishers and fire buckets.</p>	<p>All fire extinguishers are already date expired, Pic-38. No emergency guideline is written beside the fire extinguishers/hosepipe as to how to use them, Pic-39. No emergency lights to alert persons with hearing disabilities during the fire.</p>	<p>Put poster/visual guidance on how to use emergency tools besides the tool. Install emergency alerting lights. Emergency Exit shall comply with section 3.4.1.16. Emergency exit, page-47.</p>

Pic-39: Fire buckets need to be placed and equipped properly

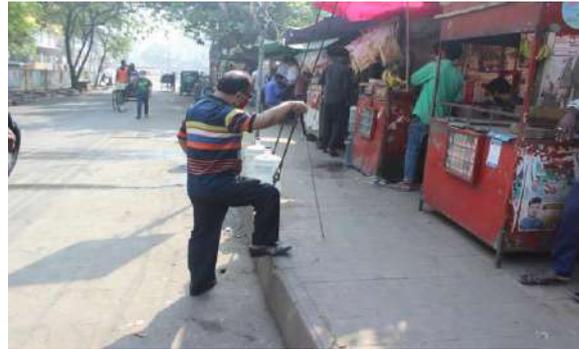
Pic-41: No ramp, the footpath is not accessible

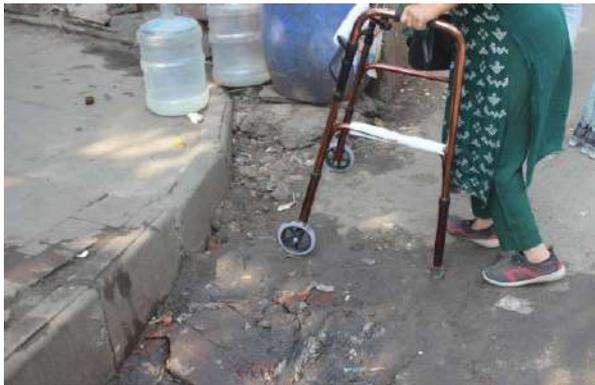
Pic-42: No curb ramp to use footpath with a walker

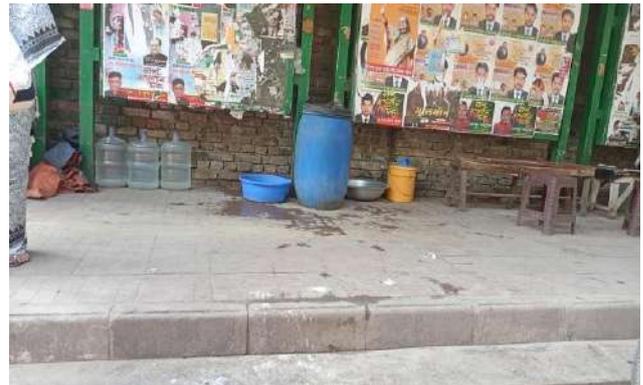
Pic-43: Bus stoppage used by street food vendors

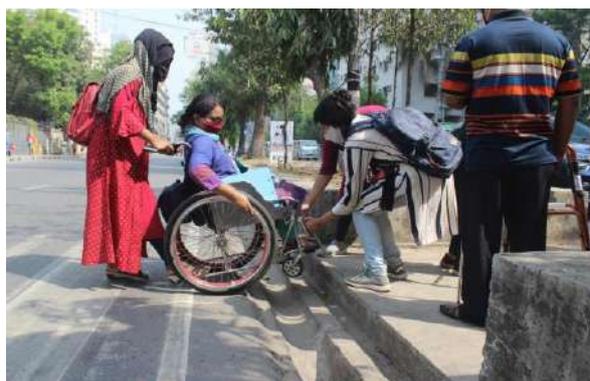
Pic-46: No gratings or curb ramp between street and divider cut through

Findings	Gaps	Recommendations
<p>Once we reach the beginning of the footpath, there is a landing 1372mm x 1829mm after a slight and gradual slope from street level.</p> <p>The height of the footpath is 330mm.</p> <p>The footpath width varies from 1829mm to about 3048mm in some cases.</p> <p>There is directional tactile paving of 609mm.</p> <p>Changes in levels are moderately easily detectable since there are slopes and ramps.</p> <p>The tactile ground surface indicators of contrasting colour for detection of slight/drastring changes in levels are present.</p> <p>The landings are 1219mm x 1524mm at an average.</p> <p>There are zebra crossings in case of nodes and road crossings with appropriate colour contrast and proper transitions between the footpaths to the zebra crossings.</p> <p>One impromptu bus stoppage is there where buses usually stop and people gather in lines to access the service. There is a wooden table used as a ticketing counter with 762 mm in height. Neither seating nor waiting area is available since it is a make-shift bust stop and not a proper one.</p>	<p>The pathway width does meet the standard of a one-way wheelchair clearance.</p> <p>There are obstructions such as trees on the walkway, and electric poles in some places.</p> <p>There are some gratings on this side of the footpaths that are properly covered but the spacing (opening width) 58mm are not according to the standard, Pic-45.</p> <p>The gratings have elongated openings, and are not placed so that the long dimension is perpendicular to the dominant direction of travel. This disrupts the movement of wheelchairs.</p> <p>In case of slopes, the surfaces are not well-drained and non-slip.</p> <p>There are no proper indications, signage, or pictographs on the roadside.</p> <p>There is no proper signal control and traffic control in case of crossings, nodes and no provision for auditory alerts or proper signage for traffic control systems.</p> <p>Footpaths are being used by two-wheeled vehicles and even parked cars, causing obstruction and safety hazards to the pedestrians.</p> <p>There are no curb ramps on footpaths and no gratings or curb ramp between street and divider cut through on this site, Pic-46.</p>	<p>2.1 Pathway width shall comply with 1.4; page 42.</p> <p>2.2. Remove obstructions or alter walkway with appropriate warning signage and directional signage complies with 1.3; page 42 and unavoidable obstacles shall properly colour contrast with the background. Ensure footpath is not using any other purpose like parking vehicles, tea stalls, or vendors shop.</p> <p>2.3. Gratings: Shall be at the same level and aligned perpendicular to the direction of travel. The gap shall not be more than 12mm in any direction.</p> <p>2.4. Install appropriate signage, shall comply with 1.5; page 42.</p> <p>2.5. Ensure proper traffic control system is working, APS is recommended. Details are in section 1.6; page 43.</p> <p>2.6. Alter an accessible bus stop, shall comply with section 1.8; page 43.</p> <p>2.7. Add curb ramps between the level change of road divider cut through; shall comply with 1.2; page 42.</p>

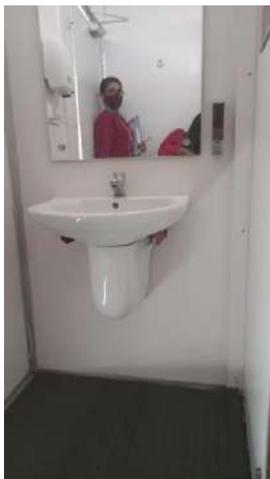
Pic-48: Narrow toilet corridor

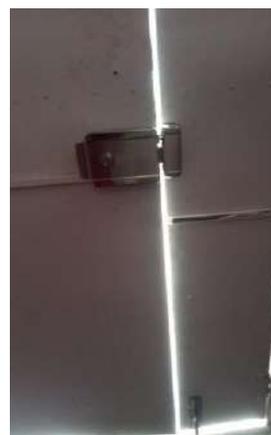
Pic-49: Heavy door at toilet

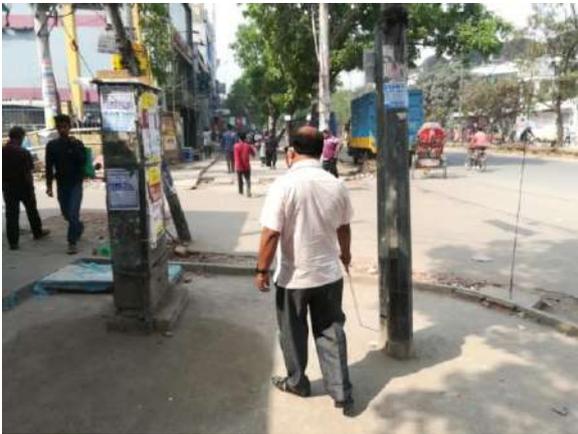
Pic-51: No tactile paving
